Re: Chrin Brothers, Inc. Landfill Cell 3D and 3E Slope Failure Investigation

**Re: Chrin Brothers Sanitary Landfill (“Chrin”)
Williams Township, Northampton County
Solid Waste Permit No. 100022
Cell 3D and 3E Slope Failure (“Slope Failure”) Investigation**

**Amended Slope Failure Report:
March 12, 2013 Chrin Brothers, Inc. Landfill
Slope Failure**

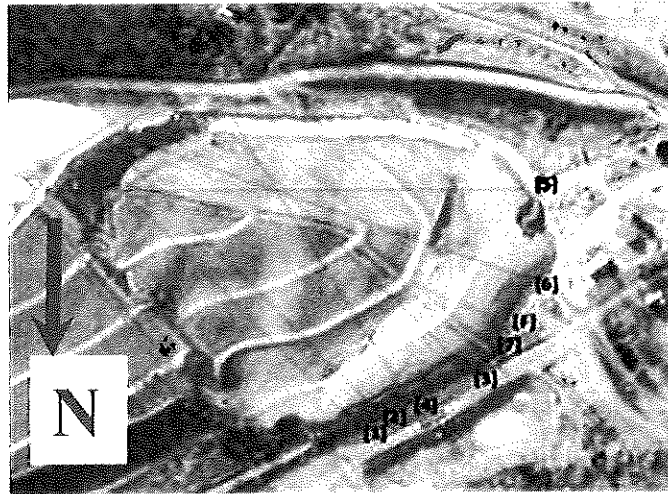
Figure 1: Aerial photograph of slide mass and cross-sections considered.

The aerial photograph in **Figure 1** shows Stages 3D and 3E after the 12 March 2013 slope movement and the location of various cross-sections (labeled 1-7 and F) used to investigate the slope failure. (An enlarged version of **Figure 1** is reproduced in Appendix B as **Figure B-4**). **Figure B-5** illustrates the direction of movement of the slide mass as estimated from the comparison of pre- and post-slide movement of gas well heads and sideslope leachate primary collection risers, which guided the location and orientation of the cross-sections.

At the top of the slope, the failure surface also passed through the MSW overlying the bottom liner system (see scarp in **Figure 1** and failure surface in **Figure 2**). A close-up photograph of the exposed waste above the bottom liner system at the top of the slope is shown in **Figure B-12**. The waste was exposed at the top of the slope for a maximum height of about 40 feet and a width of about 530 feet across the upper portion of Section 3E. The critical failure surface in this area is still the secondary geomembrane/geosynthetic drainage composite interface. **Figure B-11** shows the torn geosynthetics above the secondary geomembrane at the top of the slope just below the scarp shown in **B-12**.

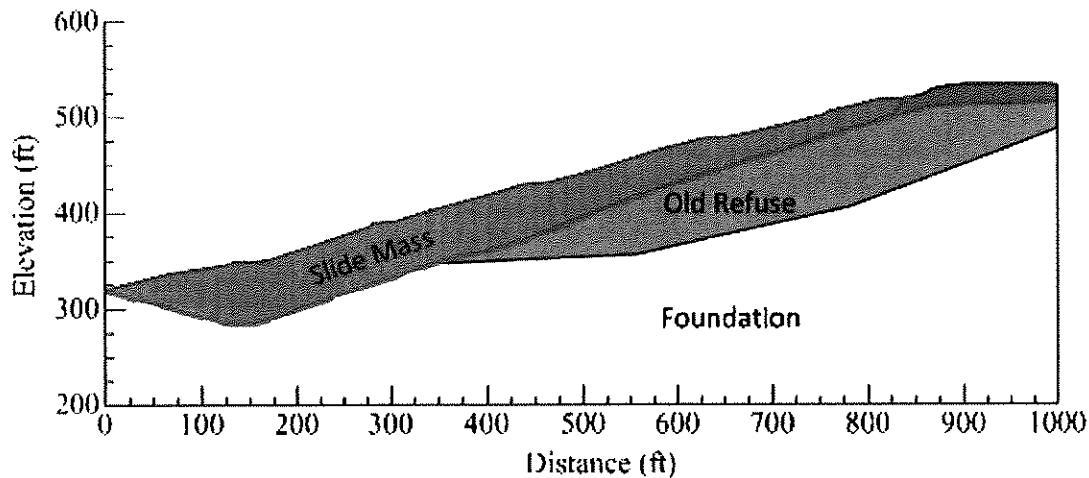
The slope cross-section shown in **Figure 2**, which is cross-section F in **Figure 1**, is indicative of the critical cross-section because it is in the direction of movement and yields the lowest static factor of safety. The green area in the cross-section in **Figure 2** is the 2013 slide mass. The waste in this area has been or is being excavated and relocated to the active area of the Landfill; the dashed red line is the 2013 failure surface that primarily parallels the geosynthetic bottom liner system in Stages 3D and 3E; the brown area is waste placed on the liner system that is still remaining above the slide area at the top of the slope; the olive green area is the old waste underlying the geosynthetic bottom liner system installed in Stages 3D and 3E; and the grey area is the bedrock and soil foundation underlying the above materials. **Figure 2** also shows the majority of the bottom liner system consists of a sideslope liner system and a small flat area at the bottom of the waste bowl in Stage 3D. The sideslope and flat portion are consistent with the terminology used in Stark and Poepfel (1994).

Figure 2: Representative cross-section of slope prior to failure.

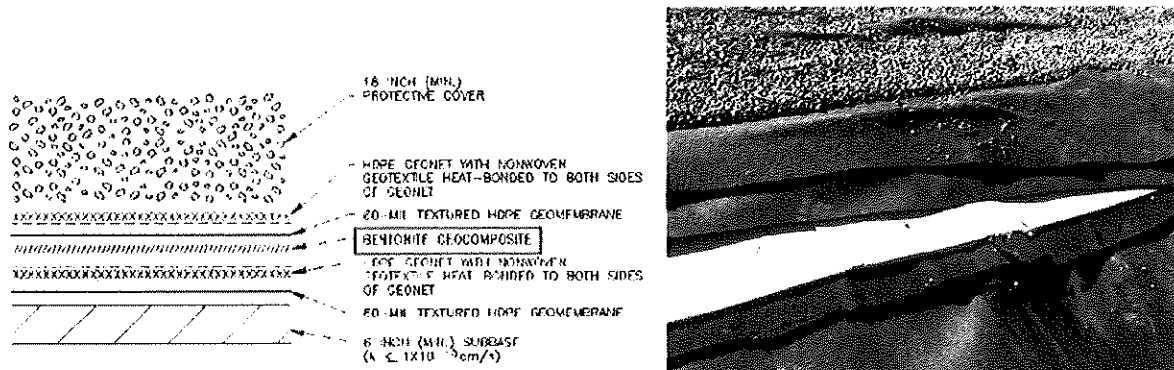
Based on the slide investigation and exhumation of the geosynthetic bottom liner system, the primary 2013 slope movement occurred between the top of the secondary geomembrane and bottom of the overlying geosynthetic drainage composite within the slide area. Except as discussed below in Section 4.2.2, the failure surface is confined to the bottom liner system and this interface.

Figure 3 (also enlarged as **Figure B-9**) shows a cross-section and photograph of the geosynthetic liner system installed in Stages 3D and 3E. The secondary geomembrane is the bottom geosynthetic and is overlain by the leak detection geosynthetic drainage composite and was the critical interface for the slide mass (see red arrow in **Figure 3**). With proper design, a textured HDPE geomembrane and nonwoven geotextile interface (see red box in **Figure 3**) can be one of the strongest interfaces in a typical composite geosynthetic liner system due to the “Velcro”

Figure 3: Cross-section of liner system in slope failure area and photograph of liner system components after waste excavation.

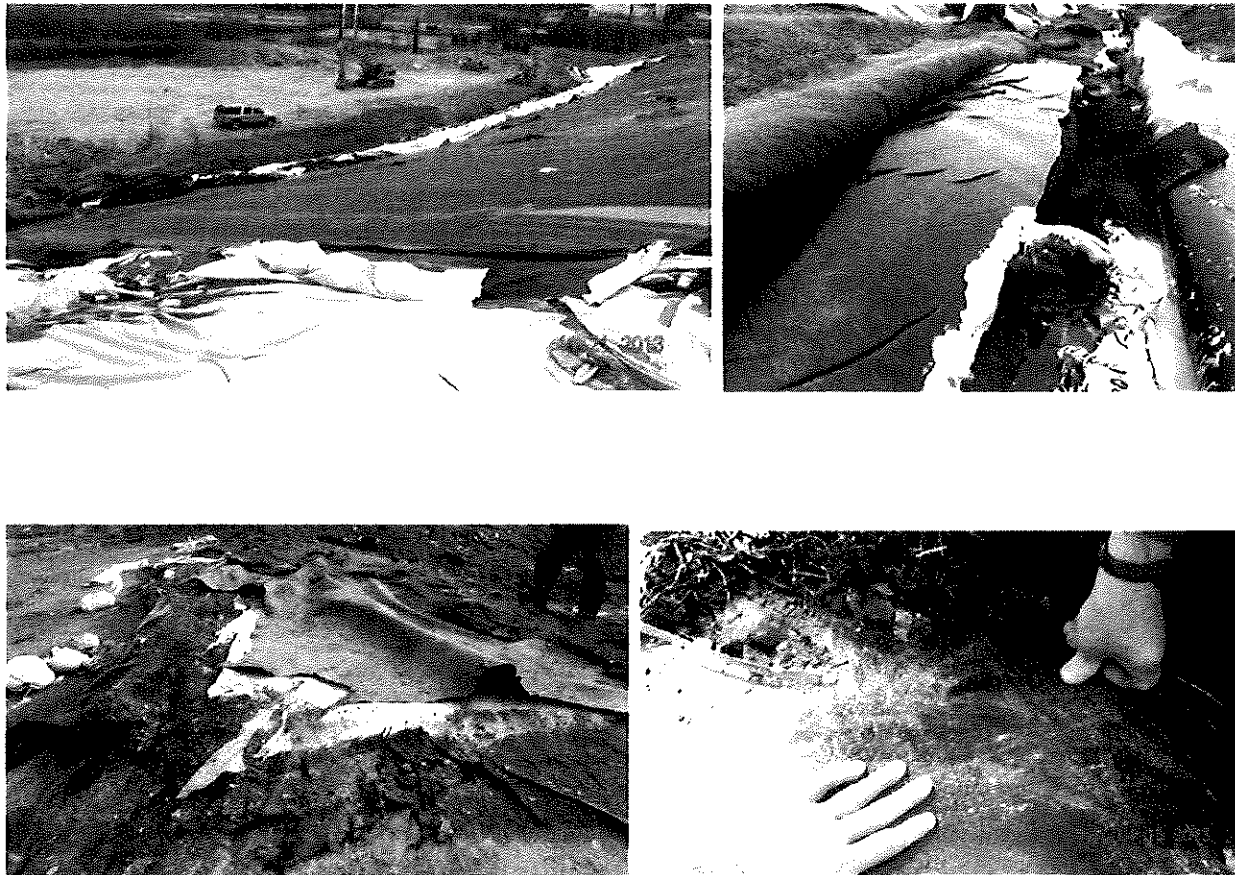
During waste excavation, the liner system geosynthetics were exhumed, inspected, and found to be significantly damaged within the slide area and adjacent to anchor trenches as shown in **Figure B-1**. Laboratory testing of the damaged geosynthetics would not yield meaningful results in the pre-failure slope stability model so undamaged geosynthetics were sought during the liner exhumation process. To obtain geosynthetics representative of pre-slide conditions, samples of the liner system components were obtained from areas just upslope and outside of the slide area and in the anchor trench along the toe of the slide mass. In the areas excavated to date, undamaged geosynthetics have been obtained just upslope of the slide mass and from the anchor trench along the northwest and northeast perimeters of Stage 3D. These locations are identified in **Figure B-2**. The process of obtaining undamaged samples just upslope of the slide mass is pictured in **Figure B-3**.

Figure B-1: Various photograph of damaged geosynthetics observed after waste excavation.

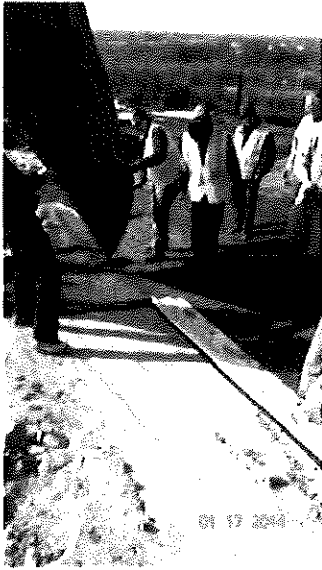
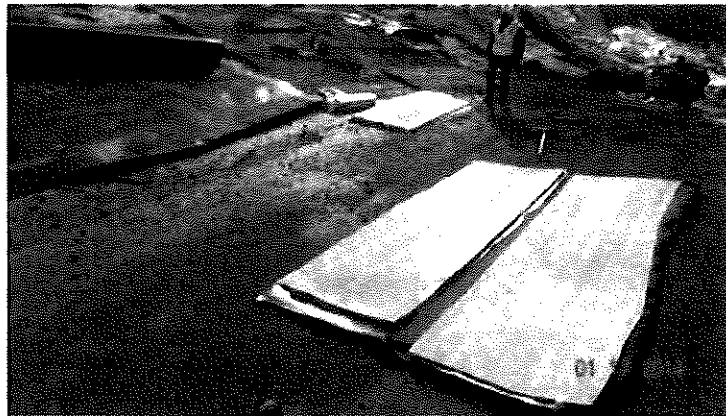
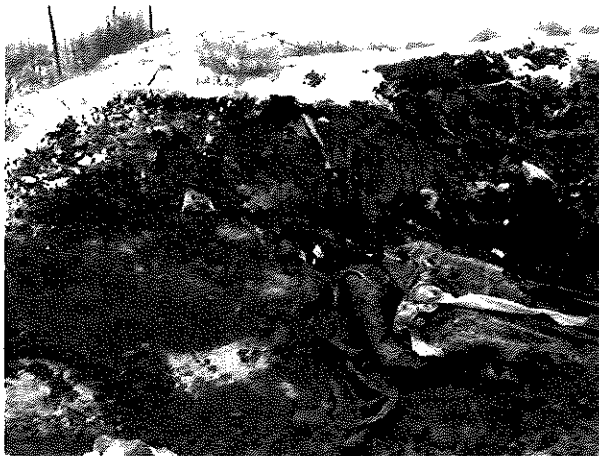
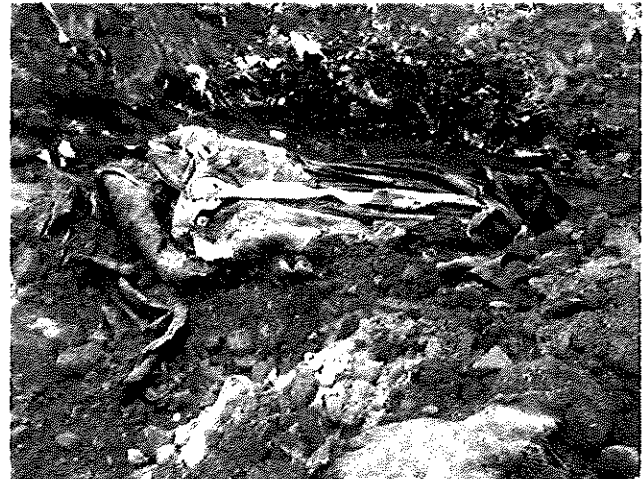
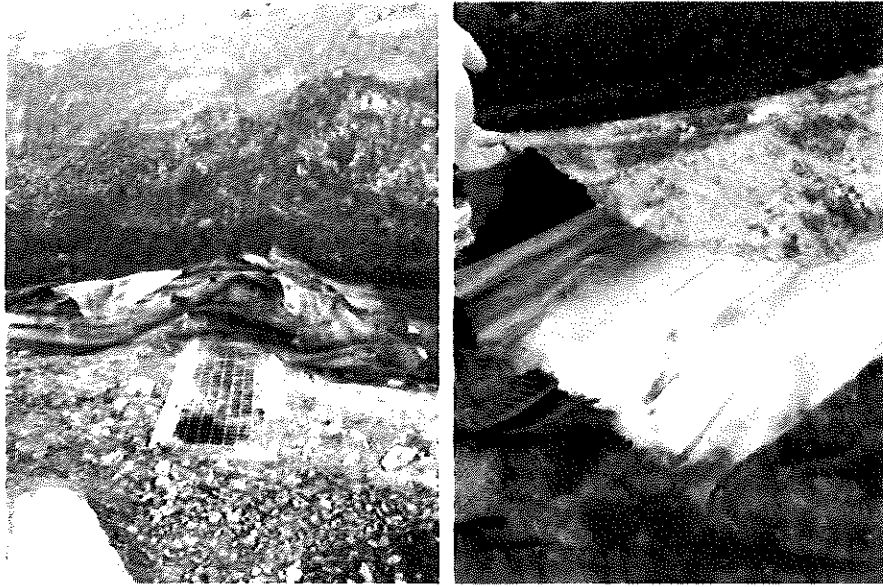
Figure B-3: Photographs of: (a) Southern Liner System Samples obtained on 17 January 2014, (b) Northeast Toe of Slope Liner System Samples on 18 March 2014, and (c) Northwest Toe of Slope Liner System Samples – 18 March 2014

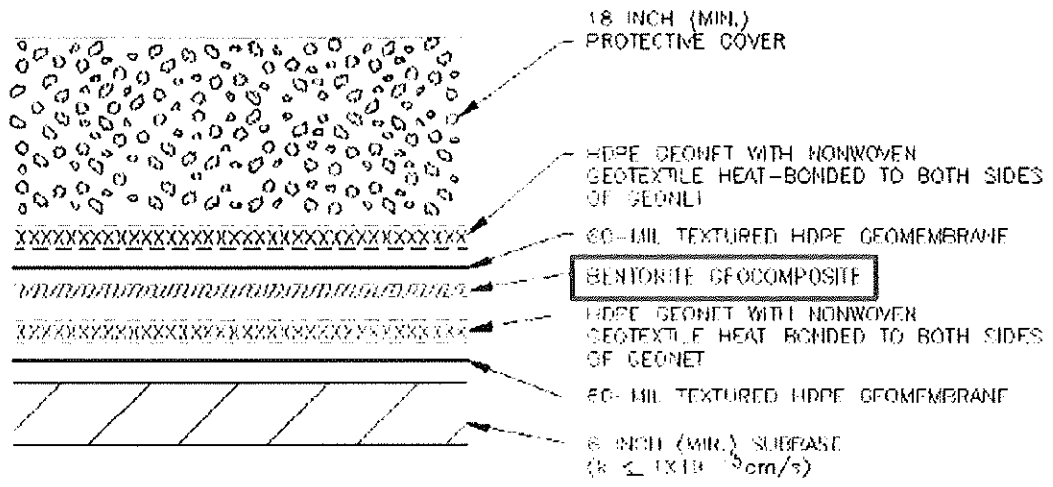
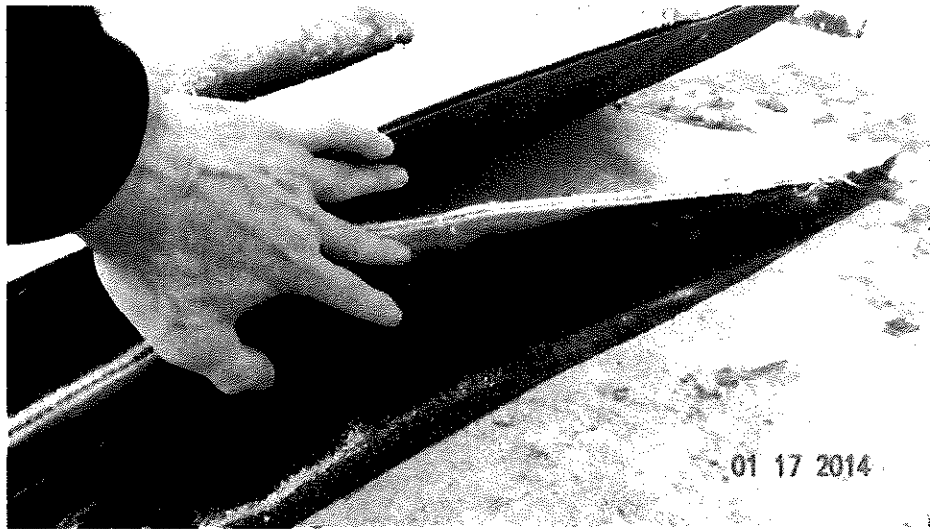
Figure B-9: Cross-section of liner system in slope failure area and photograph of liner system components after waste excavation.

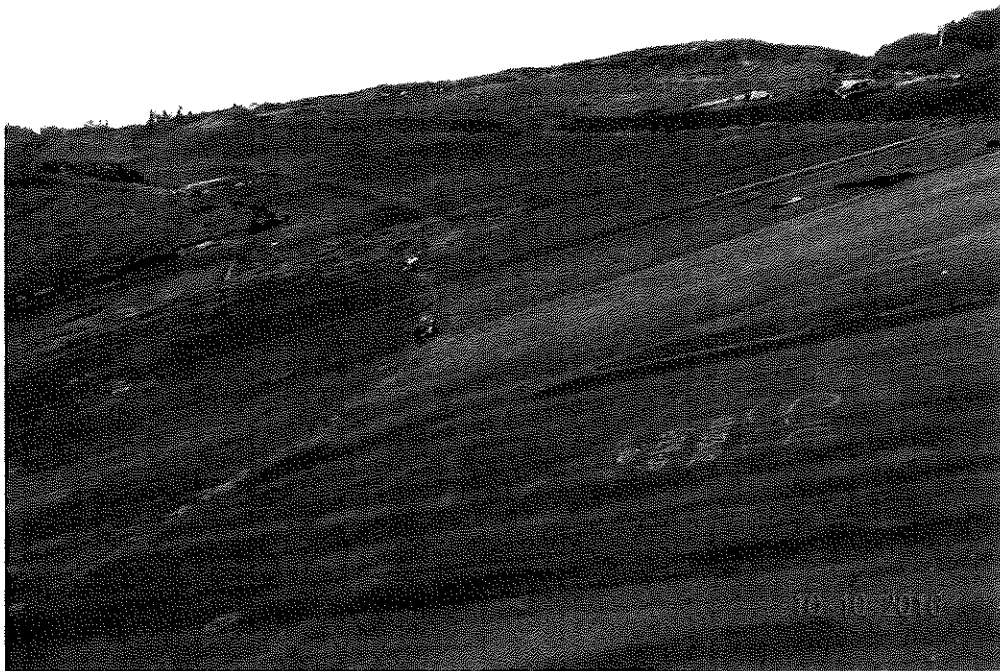
In summary, **Figure B-10** shows the exposed secondary geomembrane is still intact after waste excavation and removal of the other liner system components that moved downslope. Some of the observations confirming the critical interface are the liner system components above the critical interface tore at the top of the slope (see **Figure B-11**) and along the anchor trench, significant striations were visible on the top of the textured secondary geomembrane, and the texturing of the secondary geomembrane was either significantly worn down or completely removed by the friction of the sliding layers above it (see photo on right in **Figure B-1**). This information reinforces that the critical interface is the bottom of the leak detection geosynthetic drainage composite/top of the secondary geomembrane interface. In other words, the liner system components and waste above the geosynthetic drainage composite/secondary geomembrane interface moved downslope leaving only the secondary geomembrane still on the slope and intact. This leads to the following important conclusions about the 12 March 2013 slope failure:

Figure B-10: Photograph of secondary geomembrane still present and intact on the slope in Stage 3E and a portion of Stage 3D.

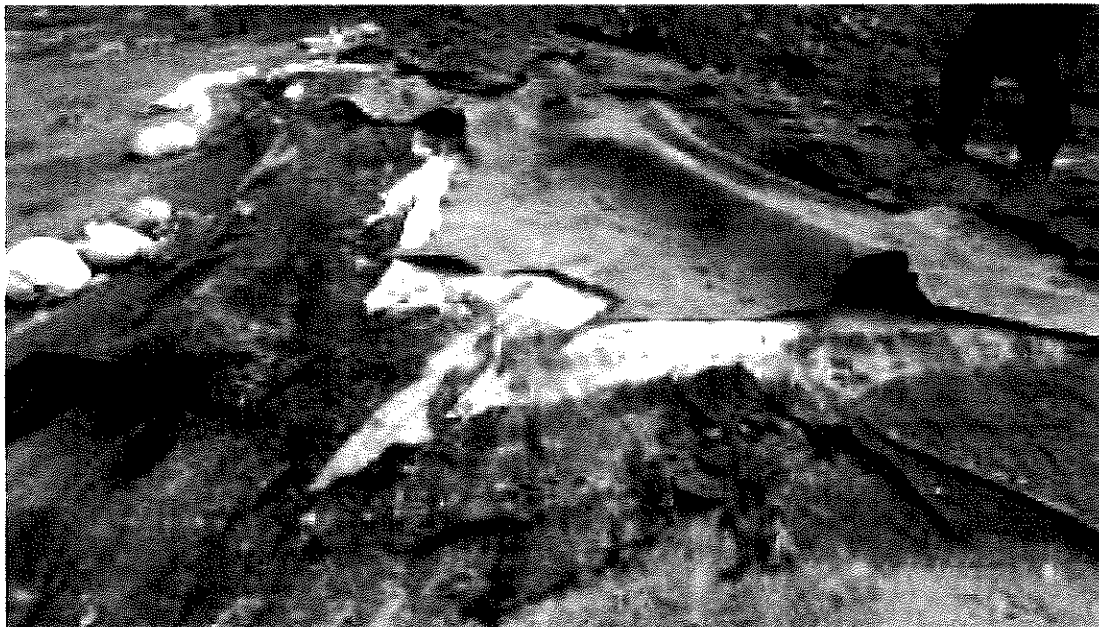
Figure B-11: Close-up of torn geosynthetics above the secondary geomembrane at the top of the slope.

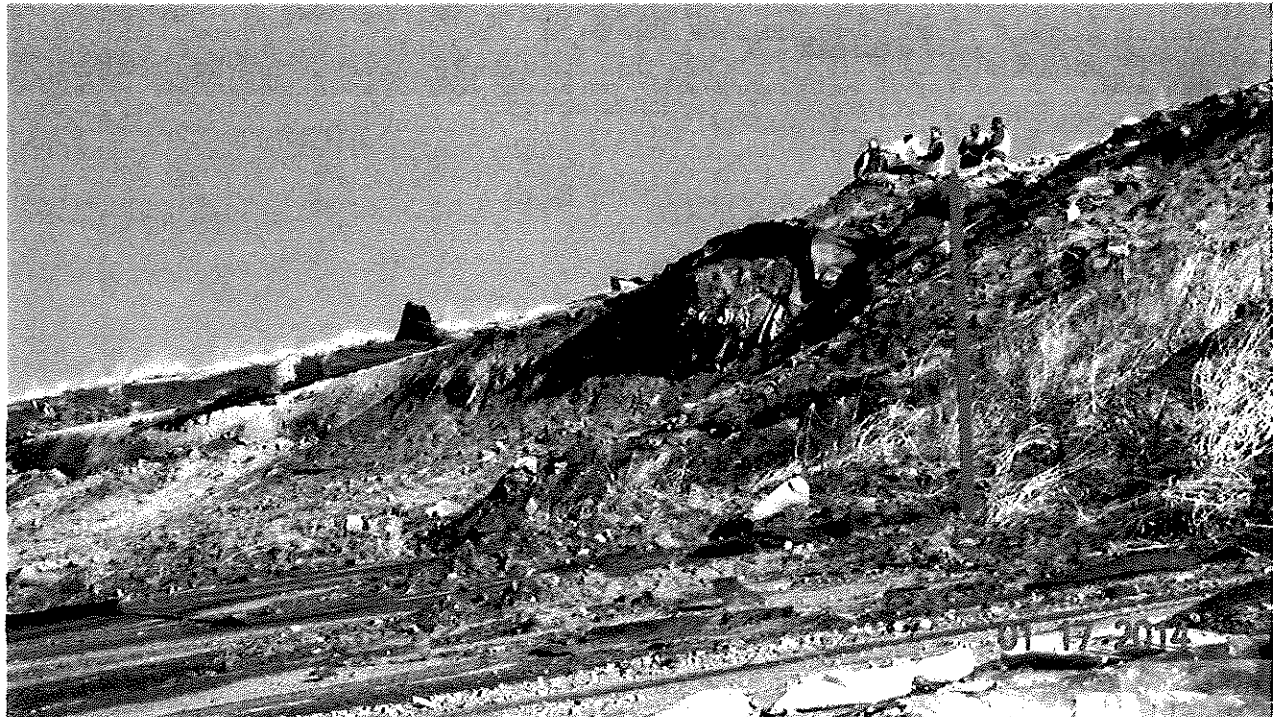
Figure B-12: Close-up of exposed waste and cover soil at top of slope (see red arrow) where failure surface exited the bottom liner system and passed through the waste.

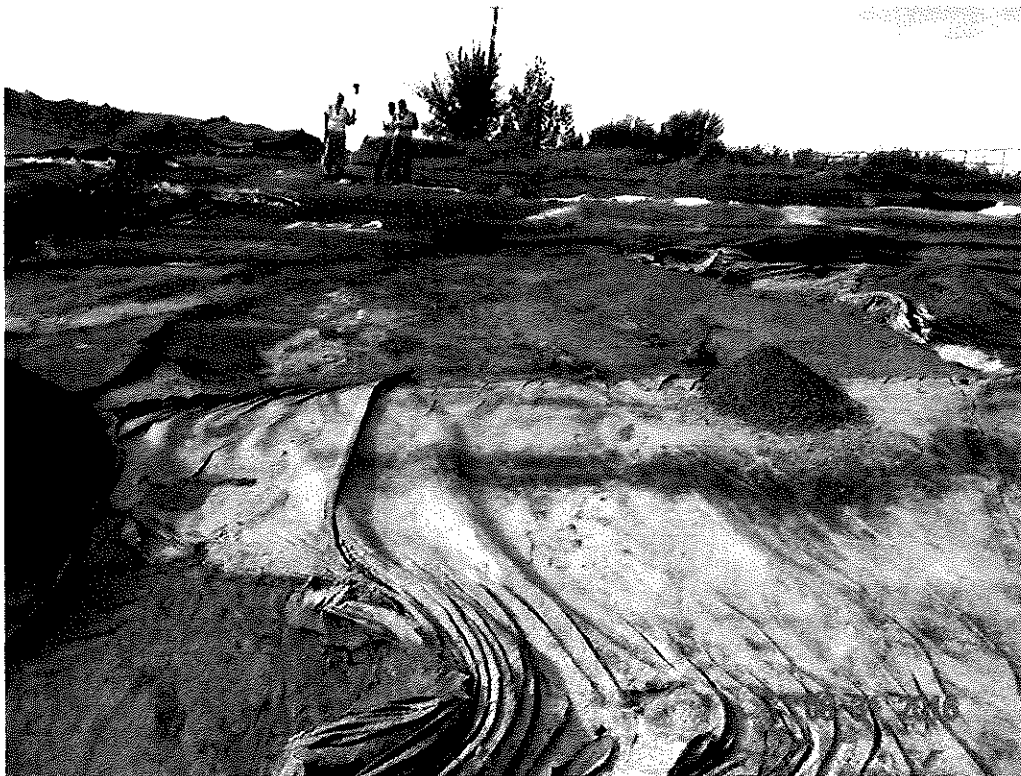
Some of the interfaces where localized/isolated movement was observed during the exhumation process include: secondary geomembrane/compacted clayey subgrade, which locally damaged the secondary geomembrane (see **Figure B-13**), geosynthetic drainage composite/primary geomembrane interface (see **Figure B-14**), and primary geomembrane/geosynthetic clay liner (GCL) interface (see **Figure B-15**). Movement on these other interfaces was observed only as a localized phenomenon and limited to areas of Section 3D in the lower one-third of the slope and in areas along the anchor trench on the southern side of the slide mass. In all instances where this observation was made, the different shear movement interface was attributed to slope and liner system geometry effects, e.g., changes in subgrade at the sides of the waste bowl and slide mass,

Figure B-13: Photograph of secondary geomembrane/compacted clayey subgrade interface movement.

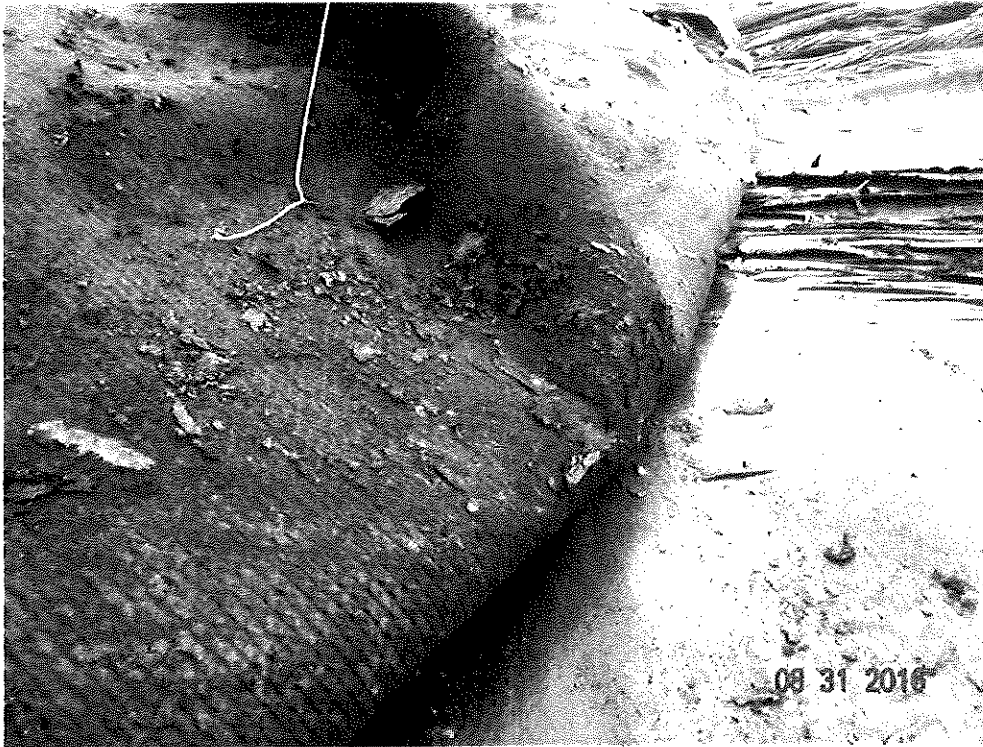
Figure B-14: Photograph of geosynthetic drainage composite/primary geomembrane interface interface movement.

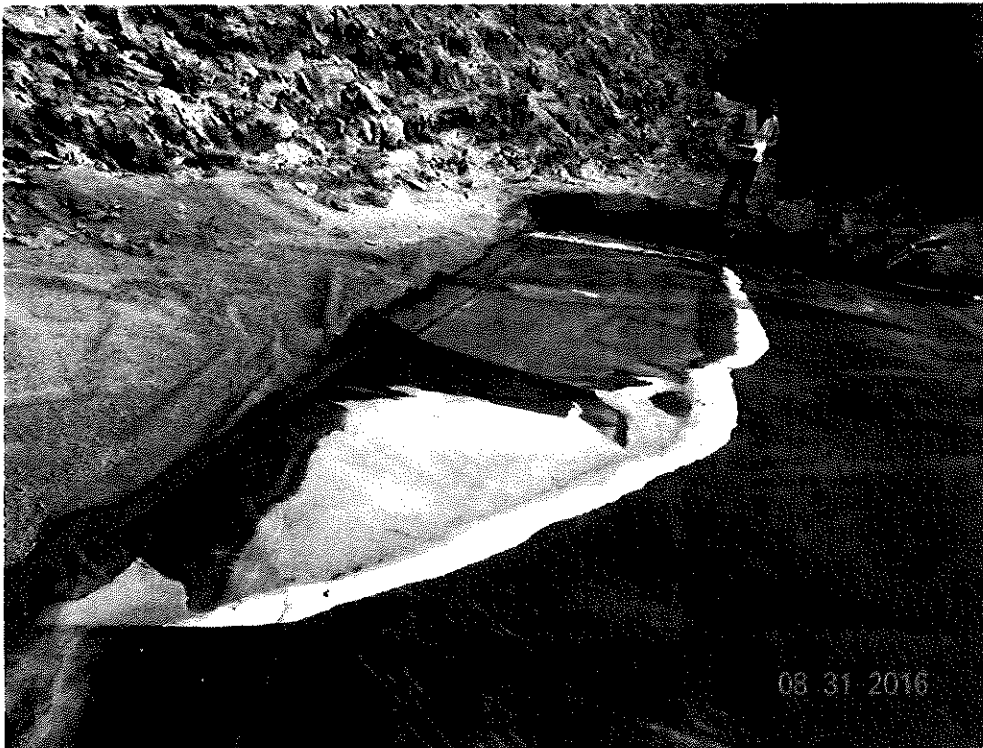
Figure B-15: Photograph of primary geomembrane/GCL interface interface movement.

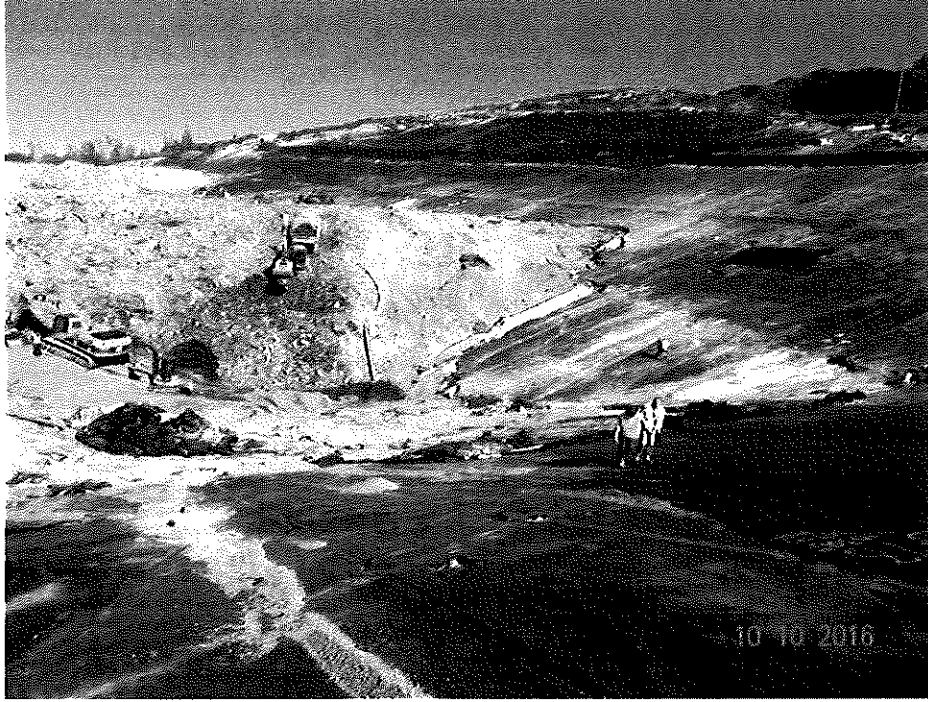
Figure B-16: Photograph of intact secondary geomembrane on slope after waste removal and removal of the damaged liner system components.

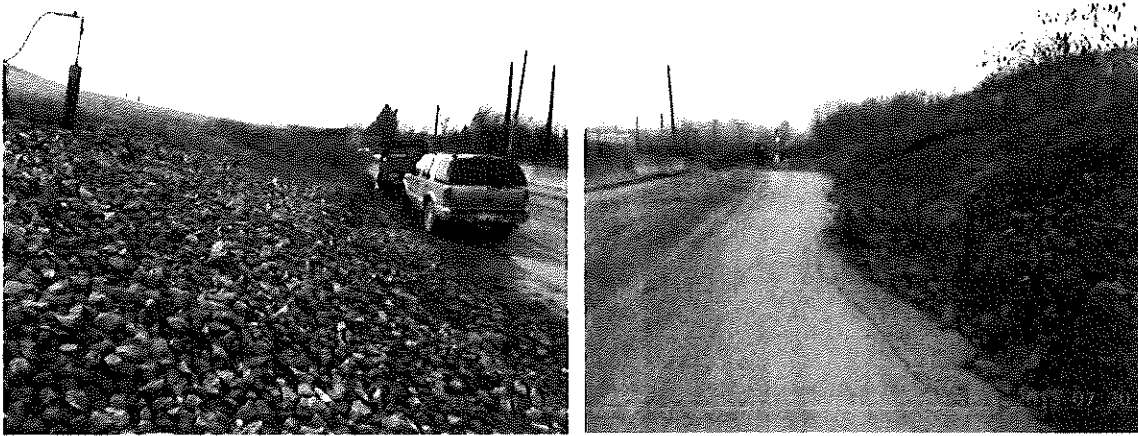
- **Excavation along the slope toe** – Prior to the slope failure there is no recorded or observational evidence of a slope toe excavation. The final cover was installed and intact for over 5 years as shown in **Figure B-18**, which shows photographs taken in December 2012 and March, 2013, prior to the slide, along the access road at the slope toe and shows no excavation;

Figure B-18: Photographs along slope toe showing no toe excavation looking: (a) northwest on 12 December 2012 and (b) northeast on 11 March 2013.

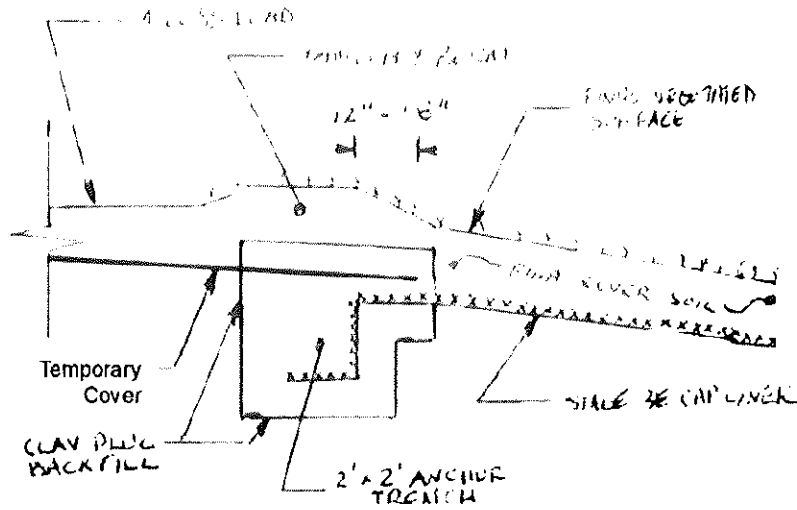
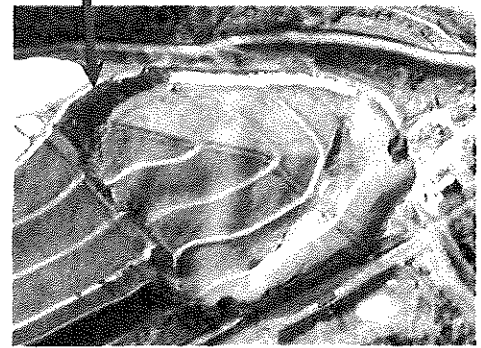
- **Precipitation Runoff and Infiltration**- Infiltration into waste mass prior to and after placement of final cover system was considered. **Figure B-19** shows the temporary cover for the area upslope of the slide area extending 12 to 18 inches downslope of the anchor trench for the final cover system in Stages 3D and 3E. As a result, precipitation and runoff

from the top of the landfill could not enter the final covered waste in Stage 3E especially due to the compacted low hydraulic conductivity clayey soil used to backfill the anchor trench for the final cover system geosynthetics (see **Figure B-19**). This temporary cover was installed in December, 2009 or about 605 days prior to the 23 August 2011 earthquake and well before the 12 March 2013 slope failure. This temporary cover system is still in-place and functioning in areas above the slide mass. Saturation of the vegetative cover soil in the final cover system due to heavy rainfall and a consequential increase in the unit weight of the cover soil was considered. However, this potential small increase in unit weight of the final cover soil did not sufficiently reduce the overall factor of safety of the slope. This conclusion is supported by the absence of any observable sloughing failure of the vegetative cover soil after final closure was completed.

Figure B-19: Schematic diagram of the tie-in for temporary cover system with final cover system for Stages 3E and 3D and photograph showing the location of the buried Temporary Cover below the access road (see red arrow).

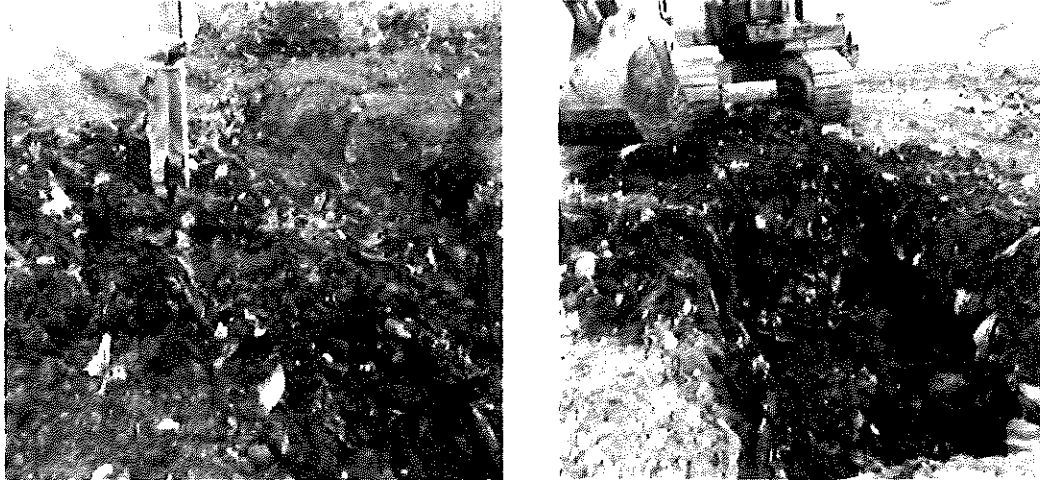
- **Waste moisture content, unit weight, and shear strength** – No large area of high moisture content or low shear strength waste has been found during waste excavation. Test pits with known volume have been excavated (see **Figure B-20**) to sample and measure the moisture content and unit weight of the waste in Stages 3D and 3E. **Figures B-21** and **B-22** provide tables of measured waste moisture content and unit weight, respectively. **Figure B-23** shows the various locations in the slide mass where the waste has been sampled and tested. The waste moisture content ranges from 12% to 55% with an average of 33% and the average unit weight of the waste is 83 pcf (47 to 120 pcf), both of which are typical for recently placed municipal solid waste (Eid et al., 2000). In addition, vertical, stable faces have been frequently excavated in the waste and readable newspapers and magazines dating back to 2003 have been regularly found during waste excavation. These analyses and observations confirm that little moisture was available in the waste to degrade the waste and that the final cover system “sealed” the new waste from precipitation. Further, no significant leachate was observed exiting the slide mass immediately after the slope failure and during the waste removal process. Finally, survey of the final cover system shows new waste settlement of only 1 to 2 feet from 2008 to 2012, which indicates good compaction and strength of the waste overlying the bottom liner system in Stages 3D and 3E;

Figure B-20: Excavations in waste to measure moisture content and unit weight.
