**Slope Failure Report:**  
**March 12, 2013 Chrin Brothers, Inc. Landfill**  
**Slope Failure**

**Submitted to the Pennsylvania Department of Environmental  
Protection Northeast Region Office**

**July 15, 2014**

**Timothy D. Stark, Ph.D., P.E., D.GE, F.ASCE**  
**Stark Consultants, Inc.**  
**P.O. Box 133**  
**Urbana, IL 61801**

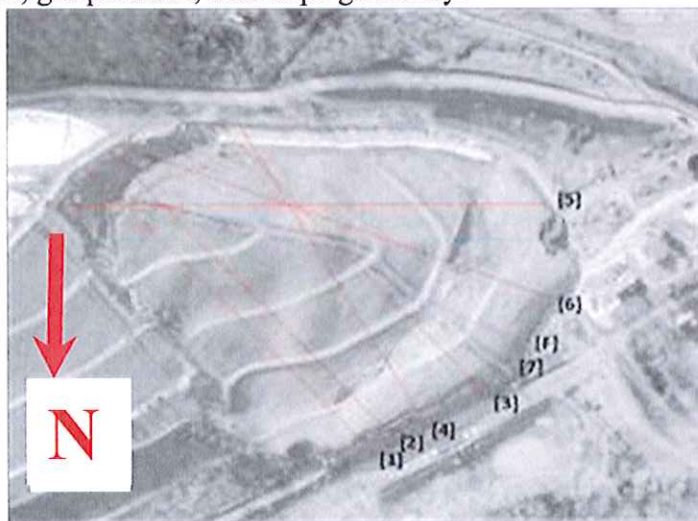
Figure 1: Aerial photograph of 12 March 2013 Slide mass slope failure; cross-sections

After 20:00 hours on 12 March 2013, approximately 12.2 acres of the landfill slope in Stages 3D and 3E of the Chrin Landfill moved downslope to the northwest. On average, the slide with an average waste depth of 38 feet, moved 73 feet downslope. The slide mass is estimated to involve approximately 770,000 yd<sup>3</sup> of waste. The slide area is pictured in Figure 1 and Appendix B; Figure B-1

The aerial photograph in Figure 1 shows Stages 3D and 3E after the 12 March 2013 slope movement and the location of various cross-sections (labeled 1-7 and F) used to investigate the slope failure. (An enlarged version of Figure 1 is reproduced in Appendix B as Figure B-1). Figure B-5 illustrates the direction of the slide mass as referenced by the comparison of the pre- and post-slide movement of sideslope leachate primary collection risers and gas well wellheads, which guided the location and orientation of the cross-sections. The slope cross-section shown in Figure 2, which is cross-section F in Figure 1, is considered representative of the critical cross-section because it is in the direction of movement and yields the lowest representative static factor of safety. The green area in the cross-section in Figure 2 is the slide mass, which is being excavated and relocated to the active area of the Landfill; the dashed red line is the 2013 failure surface that primarily parallels the composite liner system; the brown area is the waste on the liner system that is still remaining on the slope; the olive area is the old waste; and the grey area is the bedrock and soil foundation underlying the above materials.

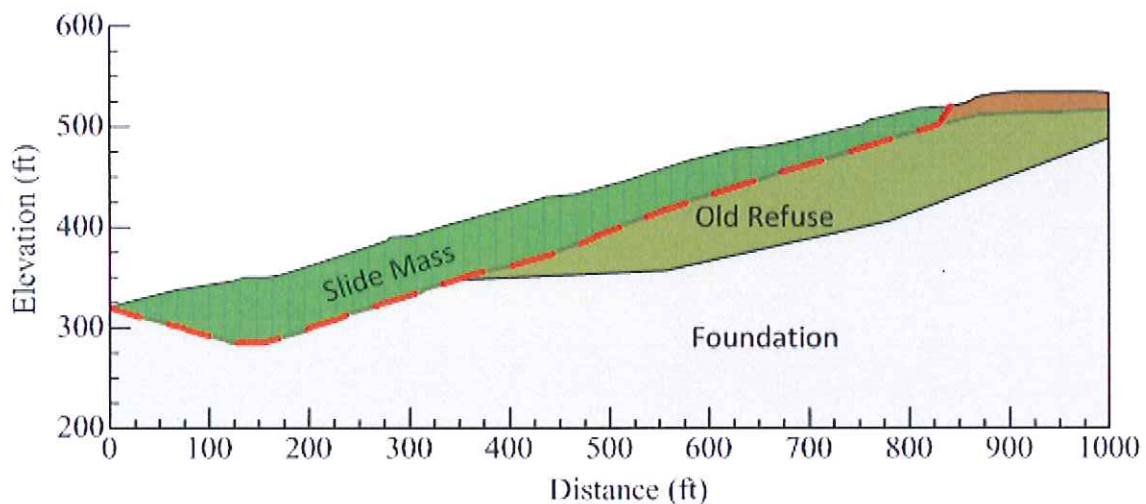
Figure 2: Representative cross-section of slope prior to failure

The slope geometry limited the slide from extending further east, i.e., into the remainder of Stage 3E, because of a significant change in the liner system subgrade topography at the eastern edge of the slide mass. Liner system contour elevations in Figures B-7(a) and B-7(b) show a significant change in liner system subgrade topography in Stage 3E and at the eastern edge of the slide mass where the subgrade topography flattens. Figure B-8 presents the topography of the subgrade ground surface and landfill liner system used to develop cross-

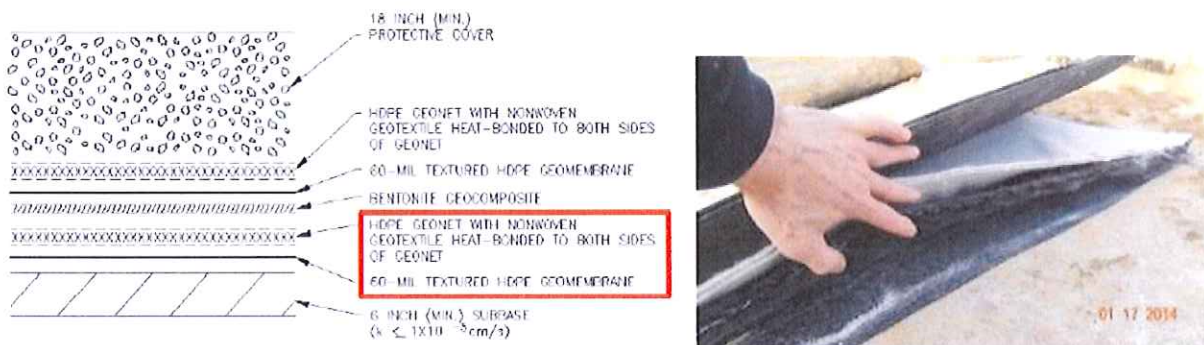
Figure 3: Cross-section of liner system in slope failure area and photograph of liner system components after waste excavation

Based on the investigation to date, the 2013 slope movement occurred between the top of the secondary geomembrane and bottom of the geosynthetic drainage composite within the geosynthetic liner system. Figure 3 (also enlarged as Figure B-10) shows a cross-section of the liner system installed in Stages 3D and 3E and highlights the secondary geomembrane and bottom of the overlying leachate detection geosynthetic drainage composite interface (see red box) which combined to create the critical interface. Figure B-10 also shows photographs of the exposed liner system after waste excavation. The critical interface in a liner system is usually stress dependent (Stark and Poepfel, 1994). As additional waste is excavated, the critical interface will continue to be evaluated along the length of the slide mass. Photographs of the secondary geomembrane and critical interface appear in Figure B-6.

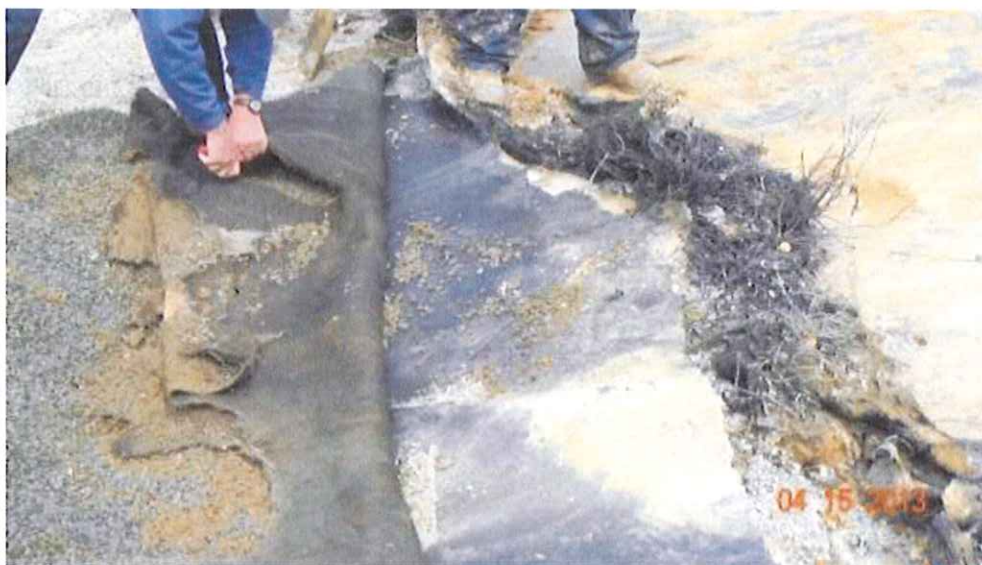
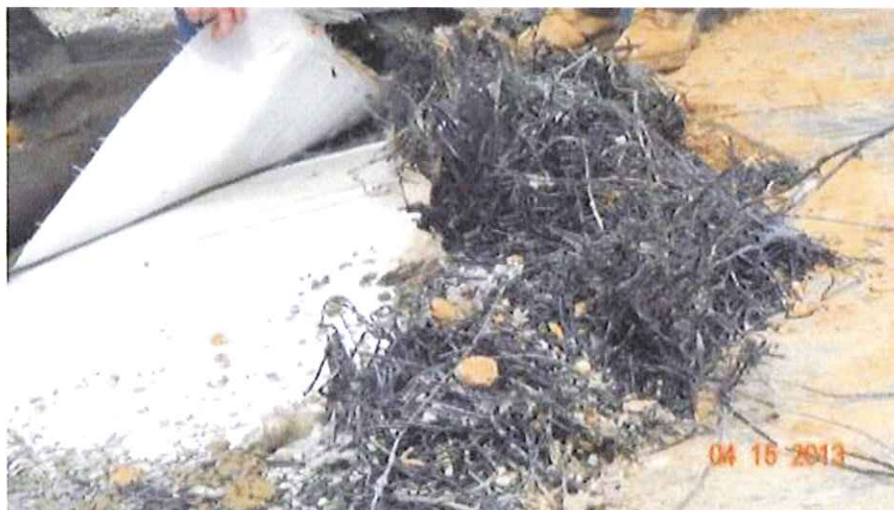
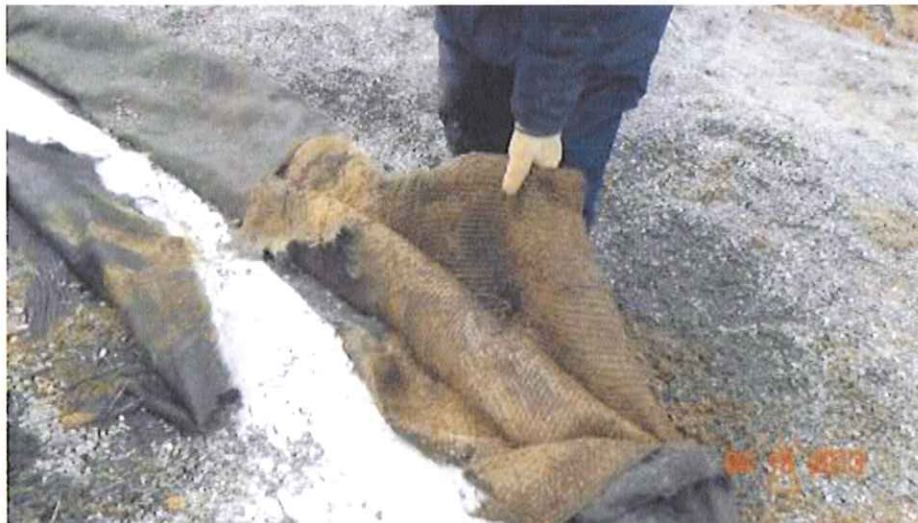
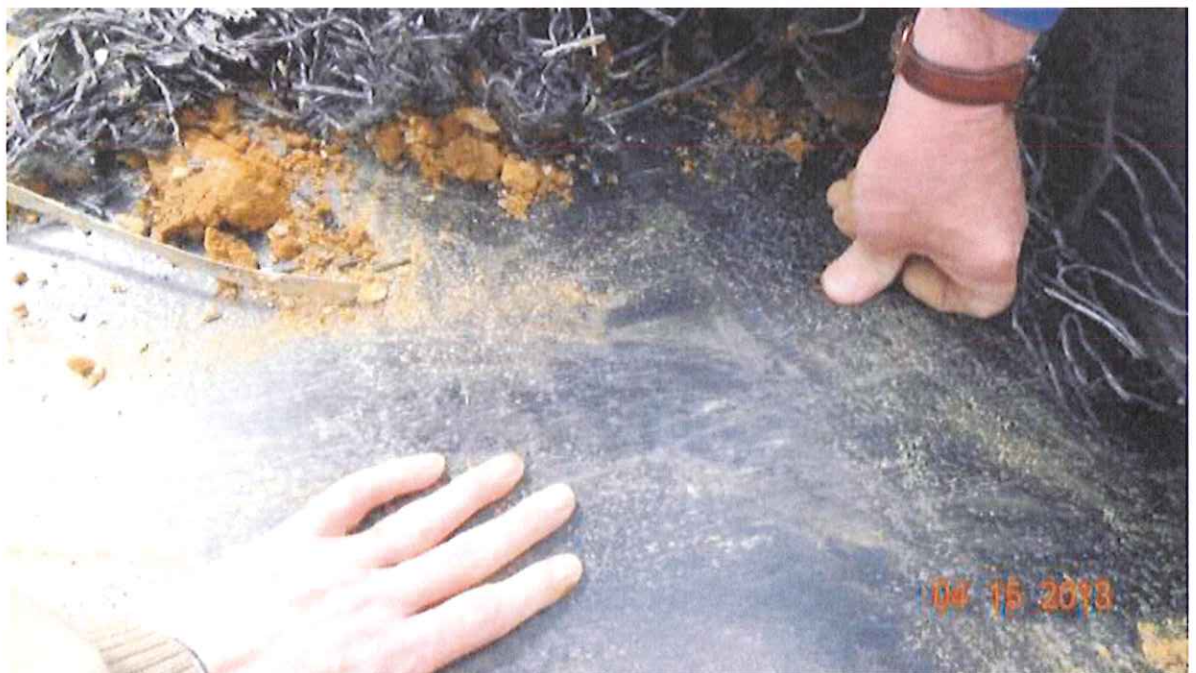
**Figure B-2:  
Post-Slide Geosynthetics**

During waste excavation, the liner system geosynthetics and soils were inspected and found to be significantly damaged within the slide area and adjacent anchor trenches due to slope movement as shown in Figure B-2 in Appendix B. Laboratory testing of the damaged geosynthetics would not yield meaningful results in the pre-failure slope stability model so undamaged geosynthetics were sought. To obtain geosynthetics representative of pre-slide conditions, samples of the liner system components were obtained from areas just upslope and outside of the slide mass and in the anchor trench along the toe of the slide mass. In the areas excavated to date, undamaged geosynthetics have been obtained just upslope of the slide mass and from the anchor trench along the northwest perimeter of Stage 3D. These locations are identified in Figure B-3. The process of obtaining undamaged samples is pictured in Figure B-4.

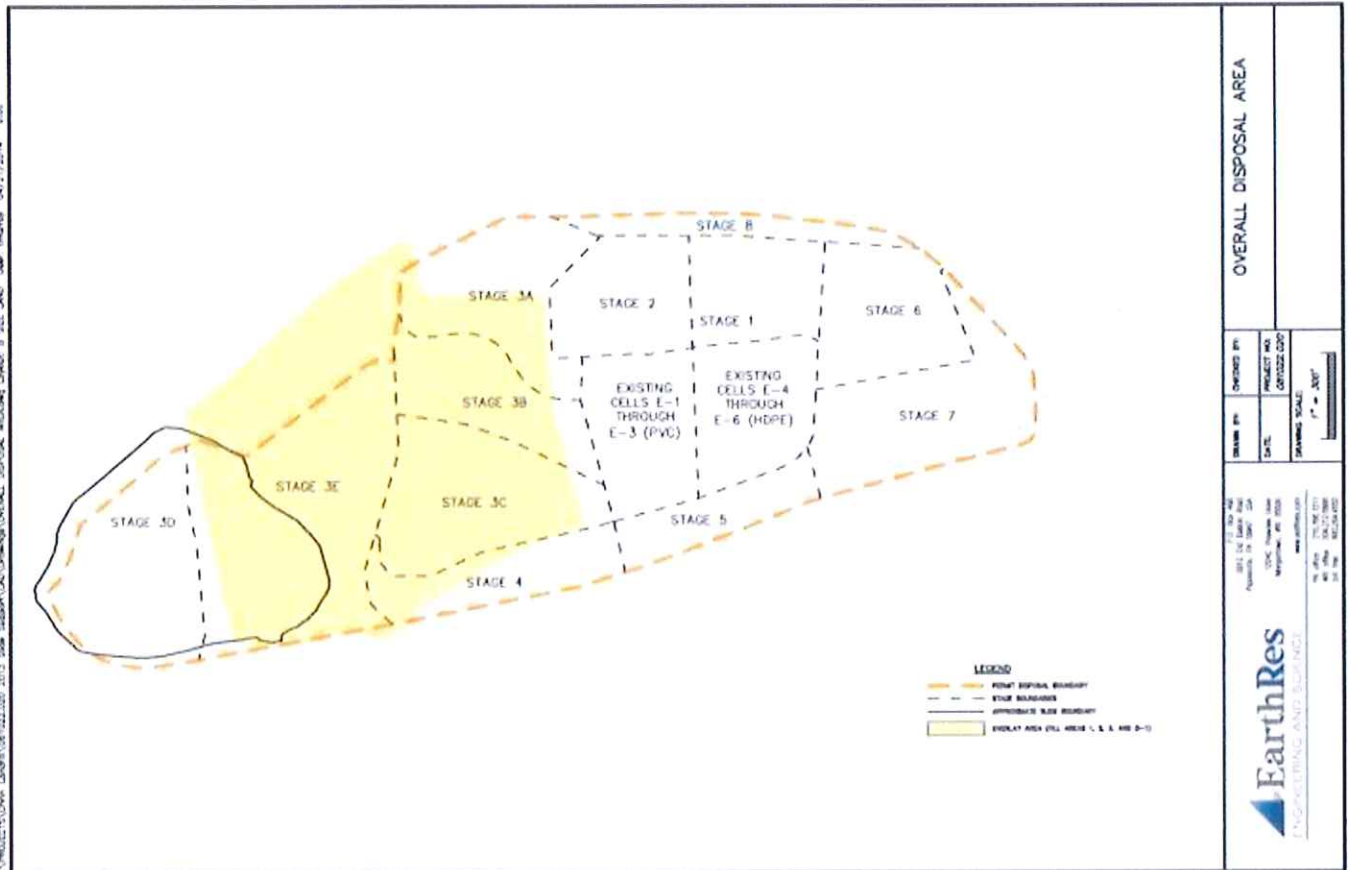
**- Figure B-9:  
Geometry of Stages 3D & 3E and Location of Old Waste Overlay**

sections 1-7. As shown on Figure B-9, part of the slide mass overlies previously disposed waste in Stages 3A, 3B, 3C, 3E, and 4.

- Precipitation – analysis of precipitation data and slope movement shows the slope movement observed between 23 August 2011 and 12 March 2013 is independent of precipitation events; and
- Placement of new waste over old refuse - This waste placement was not an apparent cause of the slope failure because the slide surface is located within the liner system which is located above the previously disposed waste.

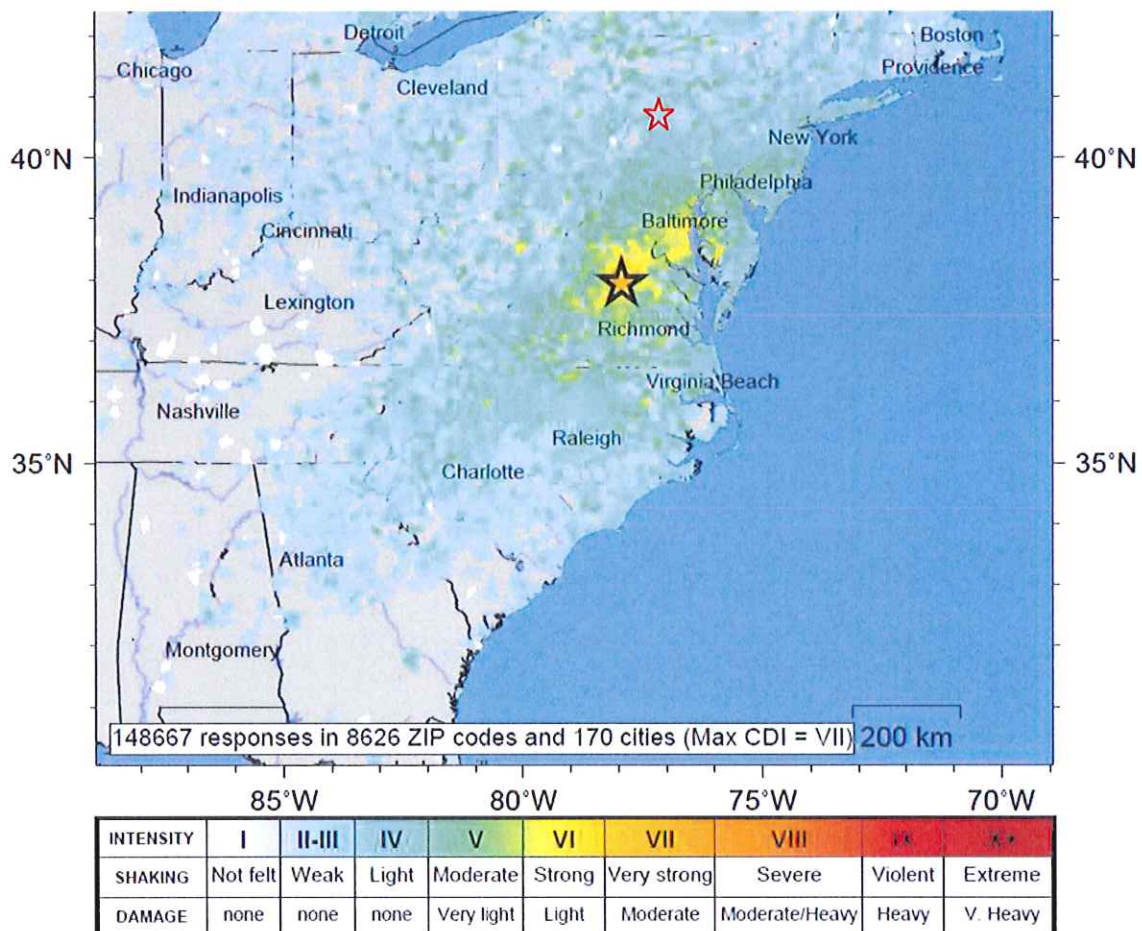
## - Figure B-12 Earthquake Information

Earthquake which occurred on 23 August 2011 (magnitude=5.8; acceleration~0.13g, depth 3.7 miles; distance 240 miles). Central Virginia Earthquake data is presented in Figure B-12. This shaking induced an estimated peak horizontal acceleration at the top of Stage 3E of approximately 0.03g which was sufficient to initiate shear displacement and a progressive failure mechanism in Stages 3D and 3E. Assessment of the earthquake accelerations at the Chrin Landfill are presented in Figures B-12 and B-13. This earthquake triggered some small downslope movement that progressed with time until the slope failed on 12 March 2013 due to shear movement along the critical liner system interface to date, i.e., top of secondary textured geomembrane.

- August 23, 2011, 17:51:04 UTC, 1:51 pm EDT
- Magnitude 5.8 at a depth of 3.7 miles
- Corbin, Virginia Bedrock Acceleration: 0.135g

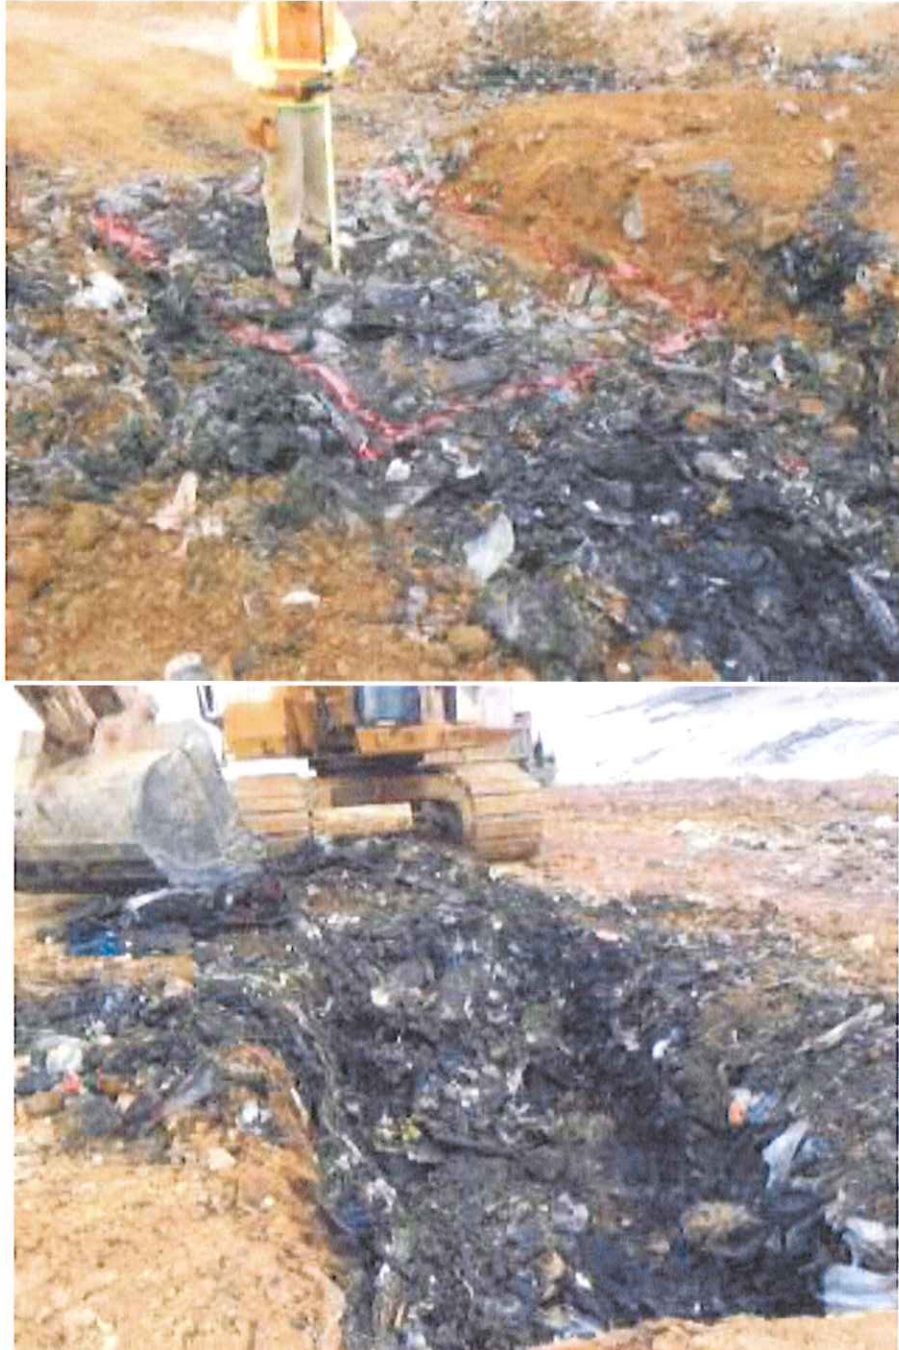
**- Figure B-14**  
**Characteristics of Waste in Slide Mass**

- Waste water content and/or shear strength of waste – no large area of high moisture content or low shear strength waste has been found during waste excavation to date. Figure B-14 provides a photograph of the typical waste excavated to date and Figure B-15 provides a table of waste moisture contents measured to date;
