### **INSPECTION REPORT – MUNICIPAL WASTE LANDFILL**

0022	Telephone # 610-25			
				Chrin Bros. Sani Ldfl.	Operator Name Chr			
				25 Industrial Drive	Address 1225 Indus	trial Driv	e	
				18042	Easton, PA 18042

Date of Inspection	5/6/2022	Identification Number	100022

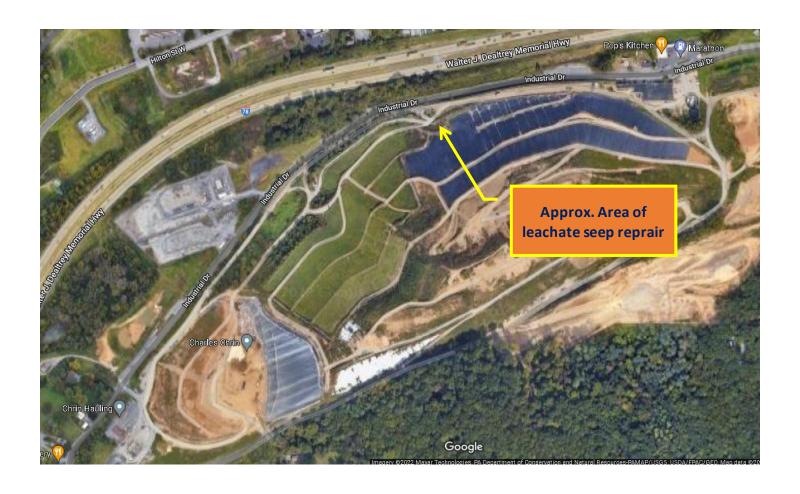
FYI – We are starting repair on a leachate seep above pump station #5 today. There is potential for some offsite odor associated with this.

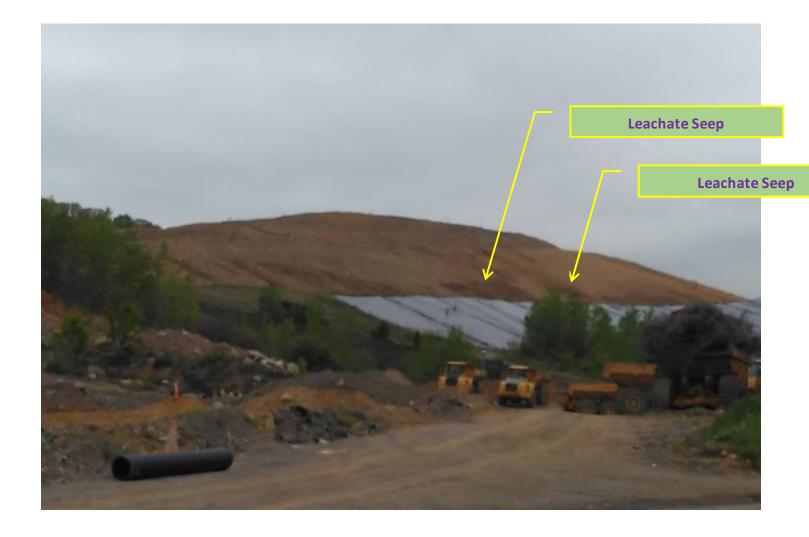
### **Leachate Seep Repair Areas (Work to be done 5/16/2022)**

We will be starting repairs on leachate seeps that have occurred this week. The repairs will take place on Monday, May 16, 2022. There is potential for odor on Industrial Drive near the 501 Maintenance building. The slopes will be recovered upon completion of the work. Please let me know if you have any questions. Thank you.

(Eastern portion of the landfill – upper slope of stage 8)
