Inspection ID: 3388217

# **Municipal Waste Landfill Inspection Report**

**Permit Number** 100022 **EPA ID Number Facility Name** CHRIN BROS SANI LDFL **Operator Name** CHRIN BROS INC **Address** 1225 INDUSTRIAL DR **Address** 1225 INDUSTRIAL DR City/State/Zip EASTON PA 18042-6829 City/State/Zip EASTON PA 18042-6829 Municipality Williams Township County Northampton **Responsible Official** Gregory Chrin **Title** Owner/Operator **Person Interviewed** Tom McMonigle **Title** Site Engineer 1 Telephone # **Lead Inspector** AMY E FAULCH Title SLD WSTE SUPV Site ID **Client ID** 42952 238053 PF ID SF ID 240650 201820 **Inspection Start Date** 07/05/2022 08:24 AM **Inspection End Date** 07/05/2022 10:30 PM RTNC - Routine/Complete Inspection No Violations Noted **Inspection Type** Inspection Result **Permit Expiration Date** 01/06/2030 **Days/Week Operated** 6 Max. Daily Volume 2000 Tons/Day

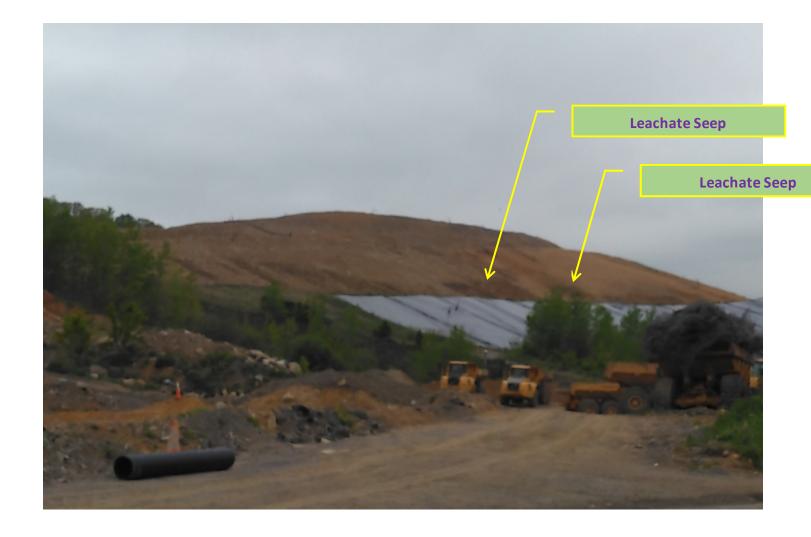
# Leachate Seep Repair Areas (Work to be done 5/16/2022)

We will be starting repairs on leachate seeps that have occurred this week. The repairs will take place on Monday, May 16, 2022. There is potential for odor on Industrial Drive near the 501 Maintenance building. The slopes will be recovered upon completion of the work. Please let me know if you have any questions. Thank you.

(Eastern portion of the landfill – upper slope of stage 8)

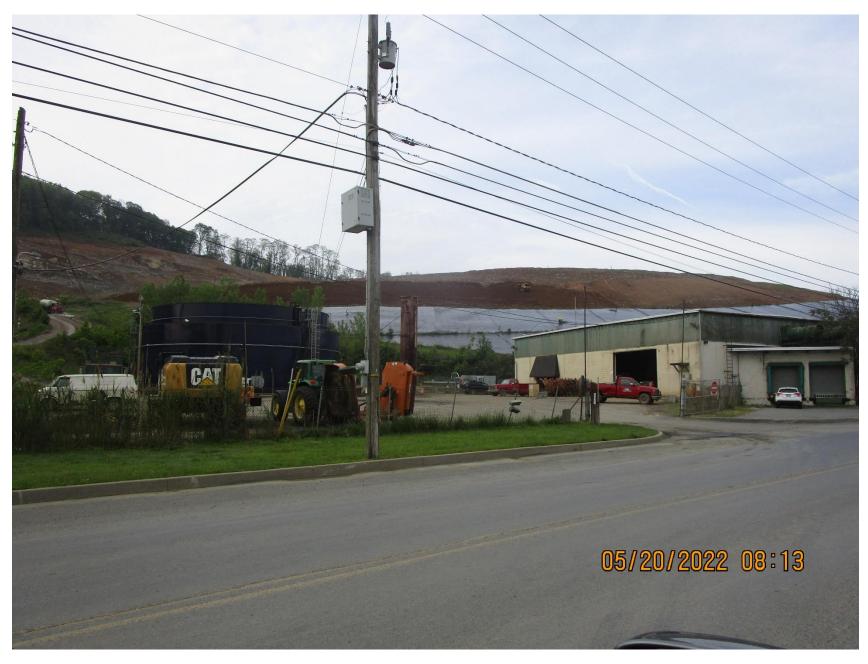
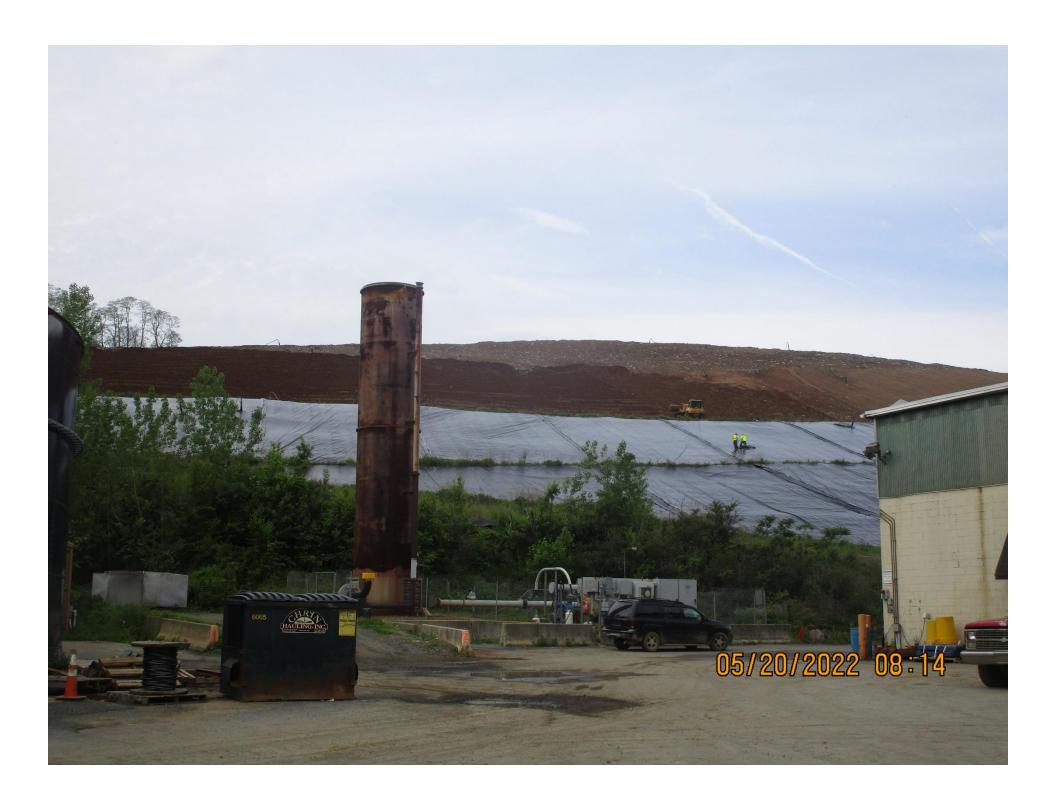
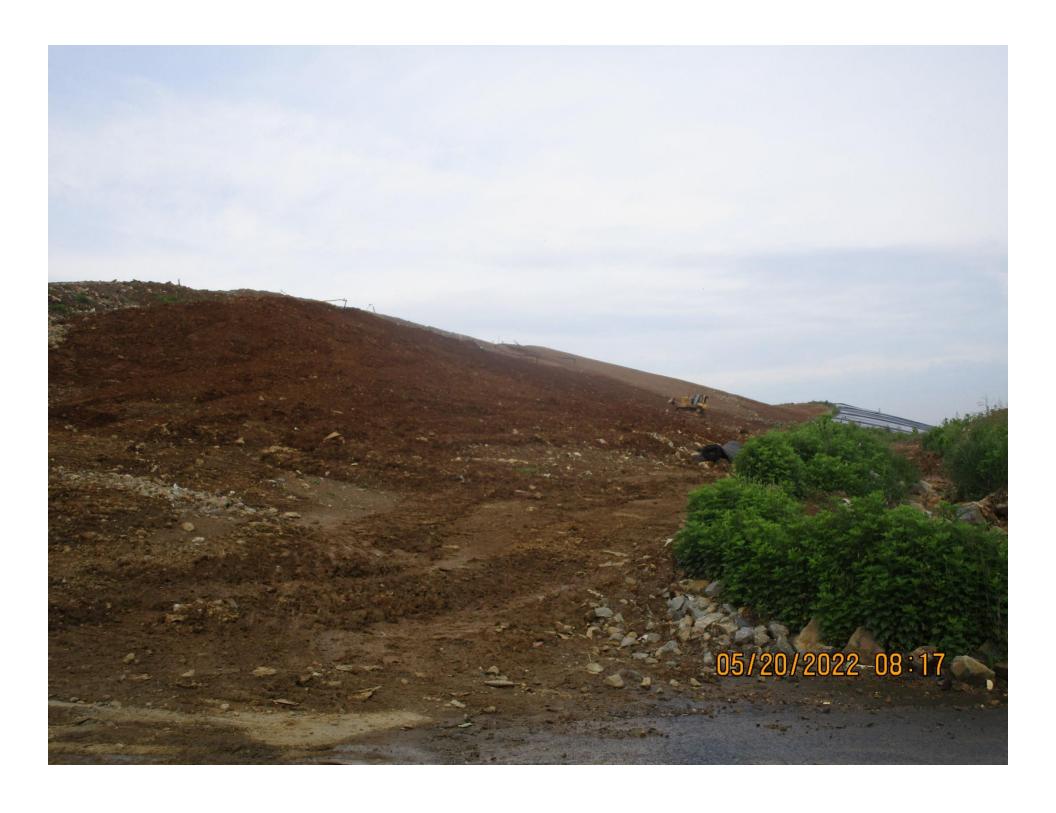
# **Leachate seep repair / slope recovering 5/20/22**

FYI – leachate seep repairs are complete and the slopes are being re-covered. Photos attached.

We were able to repair most areas yesterday. We will continue with this work today.
