## Municipal Waste Landfill Inspection Report

<b>Permit Number</b>	100022	<b>EPA ID Number</b>	----
<b>Facility Name</b>	CHRIN BROS SANI LDFL	<b>Operator Name</b>	CHRIN BROS INC
<b>Address</b>	1225 INDUSTRIAL DR	<b>Address</b>	1225 INDUSTRIAL DR
<b>City/State/Zip</b>	EASTON PA 18042-6829	<b>City/State/Zip</b>	EASTON PA 18042-6829
<b>Municipality</b>	Williams Township	<b>County</b>	Northampton
<b>Responsible Official</b>	Gregory Chrin	<b>Title</b>	Owner/Operator
<b>Person Interviewed</b>	Joseph Klobusicky	<b>Title</b>	Environmental Manager
		<b>Telephone #</b>	(484) 221-4626
<b>Lead Inspector</b>	JEREMY T SCHEIVERT	<b>Title</b>	SLD WSTE SPCST
<b>Additional Personnel</b>	AMY E FAULCH	<b>Title</b>	----
<b>Site ID</b>	238053	<b>Client ID</b>	42952
<b>PF ID</b>	240650	<b>SF ID</b>	201820
<b>Inspection Start Date</b>	11/22/2022 09:31 AM	<b>Inspection End Date</b>	11/22/2022 11:00 AM
<b>Inspection Type</b>	RTNC - Routine/Complete Inspection	<b>Inspection Result</b>	No Violations Noted

The PA Department of Environmental Protection (Department) conducted a routine complete inspection on 22 November 2022 at Chrin Bros. Sanitary Landfill (“Chrin”). Representing the Department was Amy Faulch

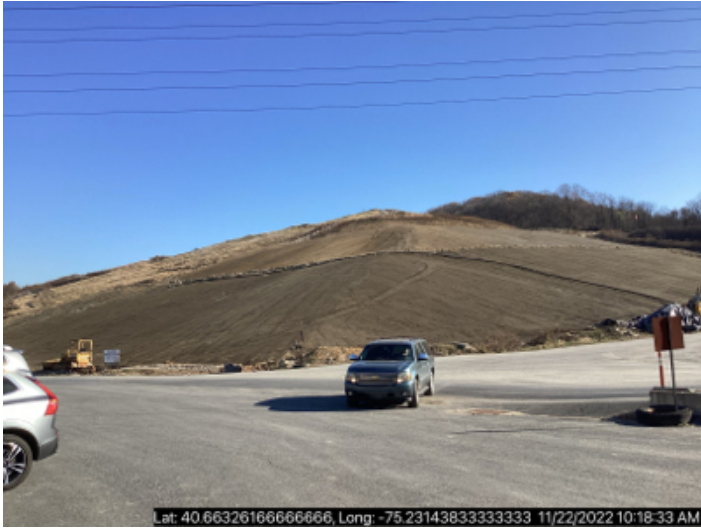
#:

The final capping project in the 3D area is concluding with seeding to follow. No immediate blasting is scheduled for the expansion project on the east end of the landfill, however work there is ongoing.

Photo # 1. 3D final capping project.
