Municipal Waste Landfill Inspection Report

Permit Number	100022	EPA ID Number	----
Facility Name	CHRIN BROS SANI LDFL	Operator Name	CHRIN BROS INC
Address	1225 INDUSTRIAL DR	Address	1225 INDUSTRIAL DR
City/State/Zip	EASTON PA 18042-6829	City/State/Zip	EASTON PA 18042-6829
Municipality	Williams Township	County	Northampton
Responsible Official	Gregory Chrin	Title	Owner/Operattor
Person Interviewed	Joseph Klobusicky	Title	Environmental Manager
Lead Inspector	AMY E FAULCH	Telephone #	1
Site ID	238053	Title	SLD WSTE SUPV
PF ID	240650	Client ID	42952
Inspection Start Date	06/09/2023 09:18 AM	SF ID	201820
Inspection Type	RTNC - Routine/Complete Inspection	Inspection End Date	06/09/2023 01:00 PM
Permit Expiration Date	01/06/2030	Inspection Result	No Violations Noted
		Days/Week Operated	6
		Max. Daily Volume	2000 Tons/Day

On June 9, 2023, the PA Department of Environmental Protection ("Department") conducted a routine complete inspection at Chrin Bros. Sanitary Landfill ("Chrin"). Representing the Department was Amy Faulch of the Department's Waste Management Program ("this inspector") and Sydnee White of the Air Quality Program. Joseph Klobusicky provided a site tour and was interviewed

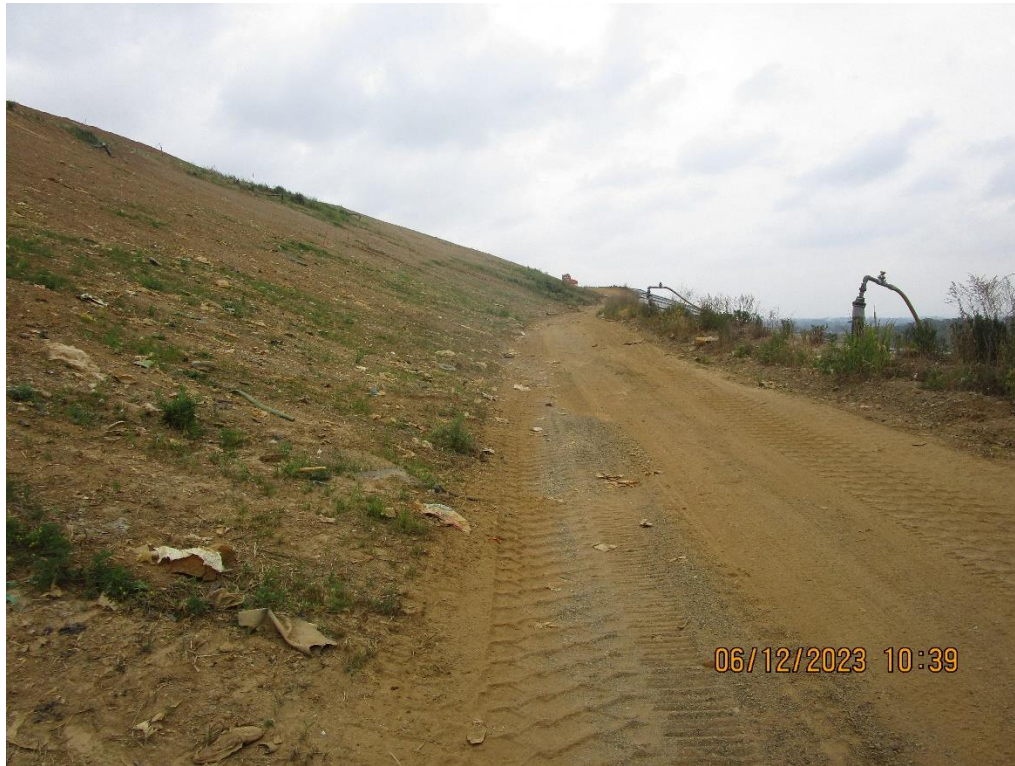
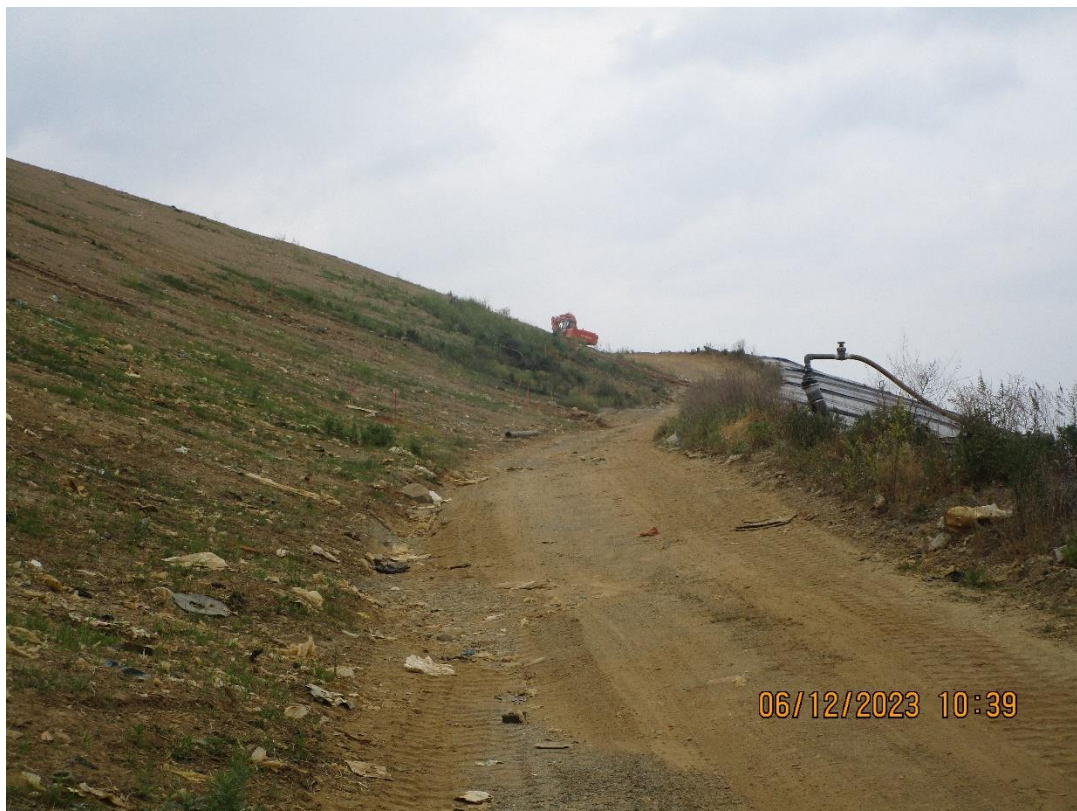
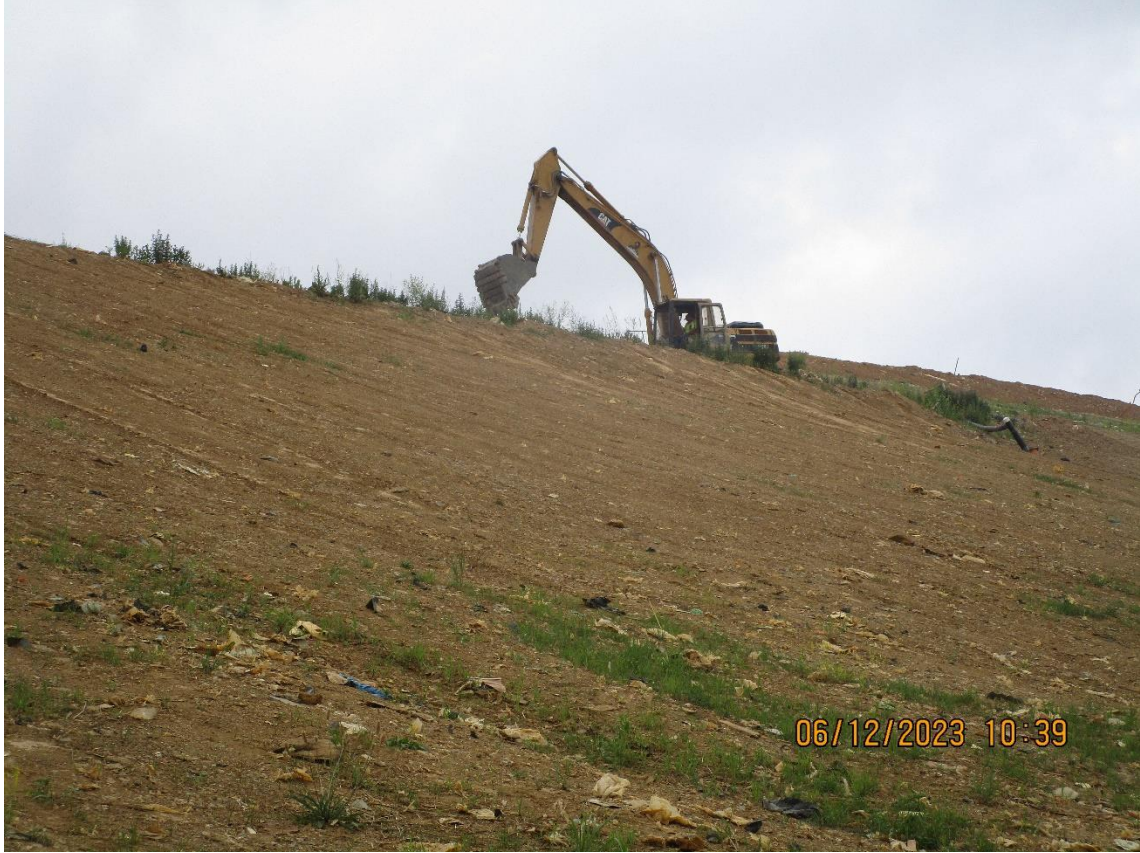
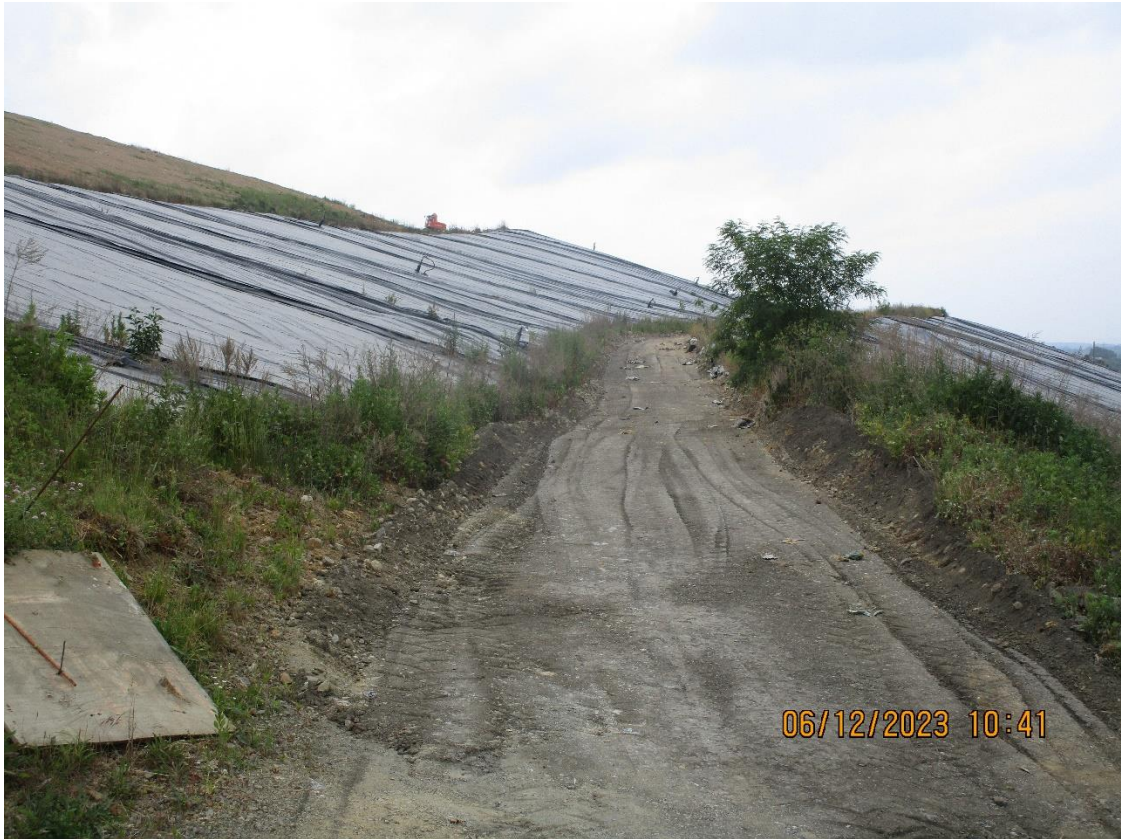
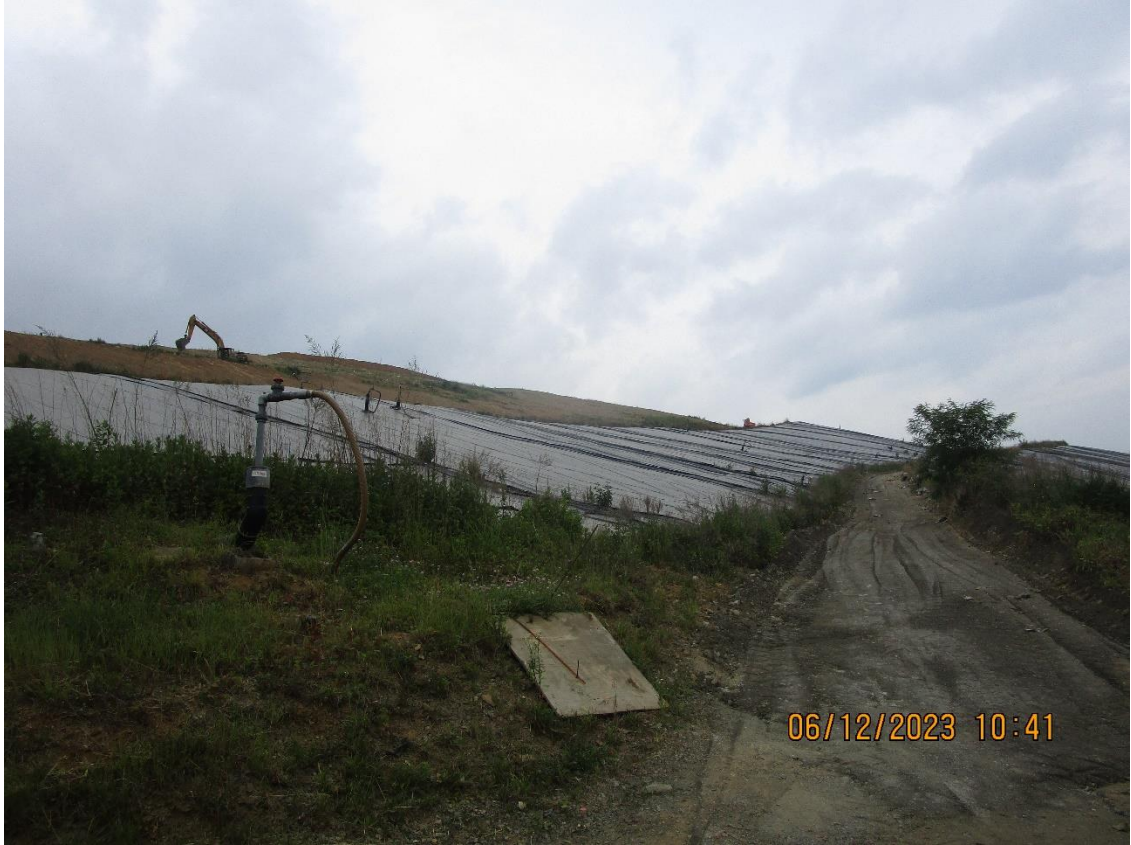
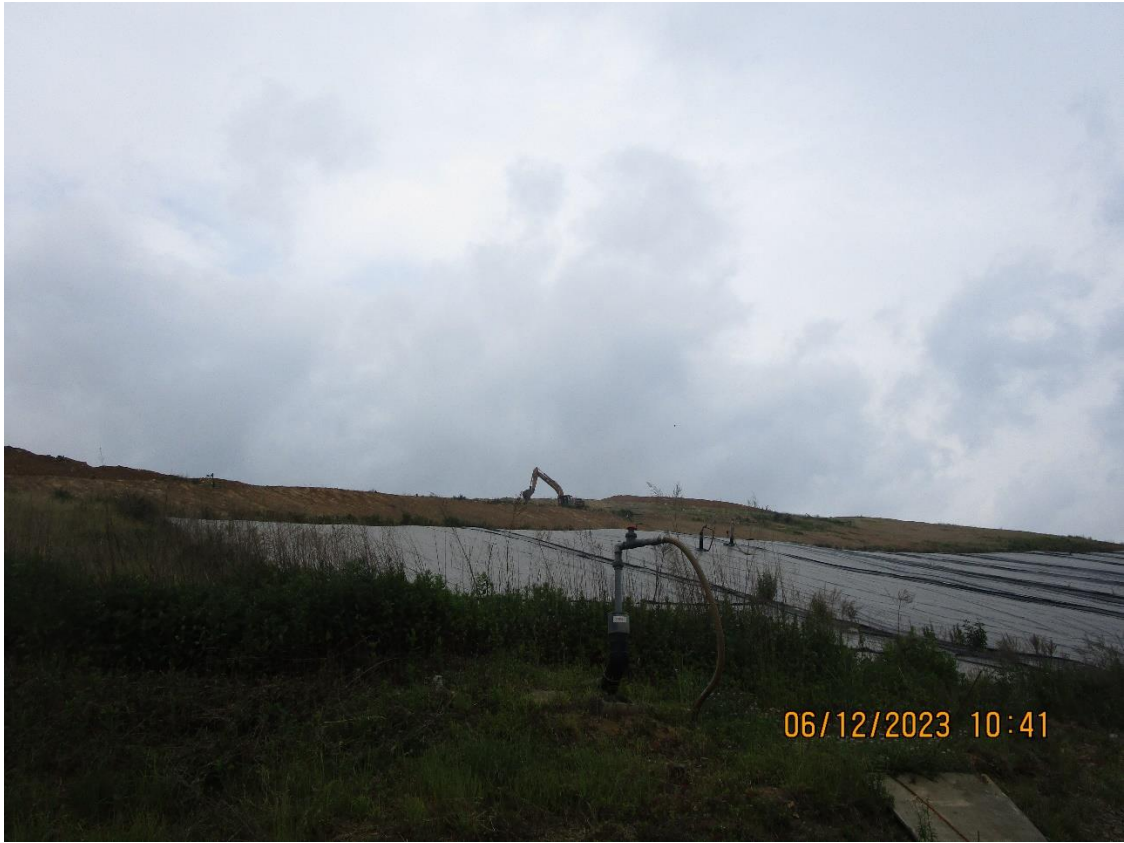
June 12, 2023 followup (leachate seep repair and bench repairs)

Here are some follow-up photos of the work we have begun.....leachate seep repair and bench road repair.

Hi Amy,
The leachate seeps have been repaired.

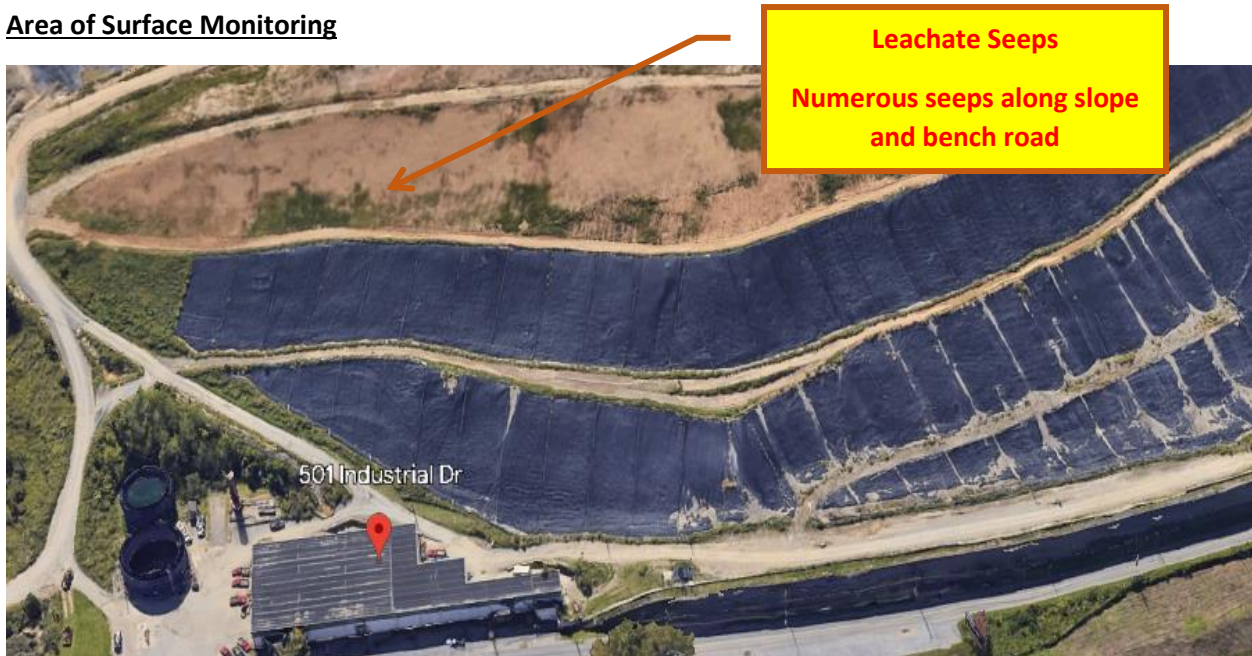
Area of Surface Monitoring

9 exceedances above 500 at well locations and surface areas were noted:

The benches on Stage 8 need to be regraded / material added (very washed out)

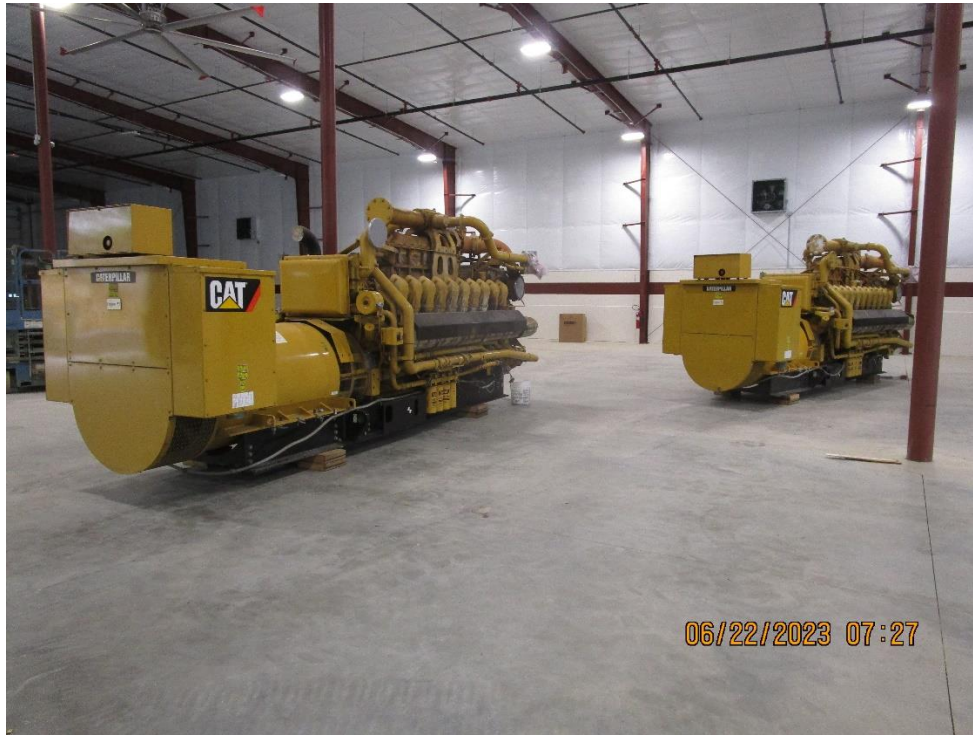
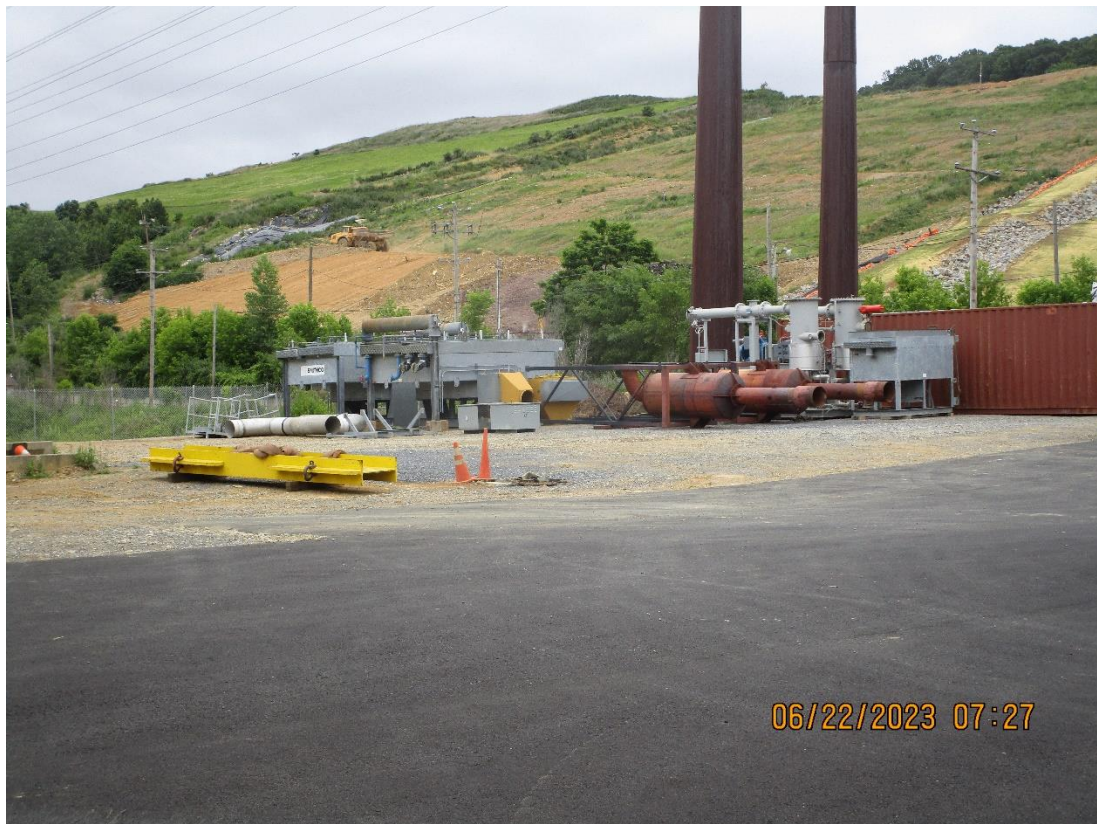
CAT Engine Delivery

June 21, 2023 – Chrin Landfill

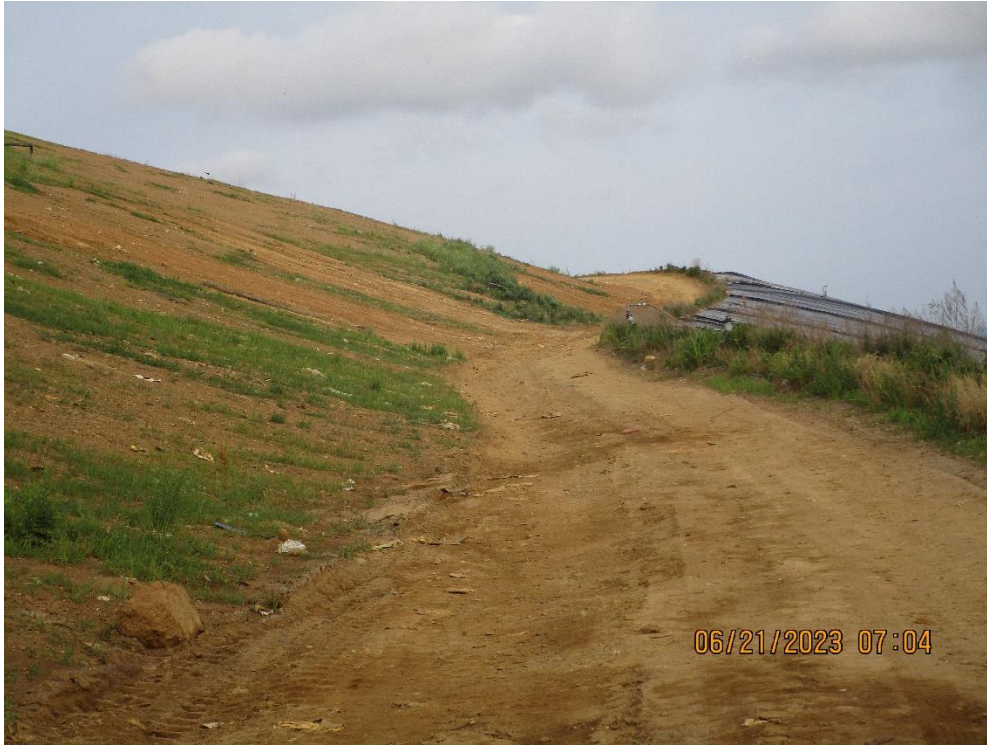
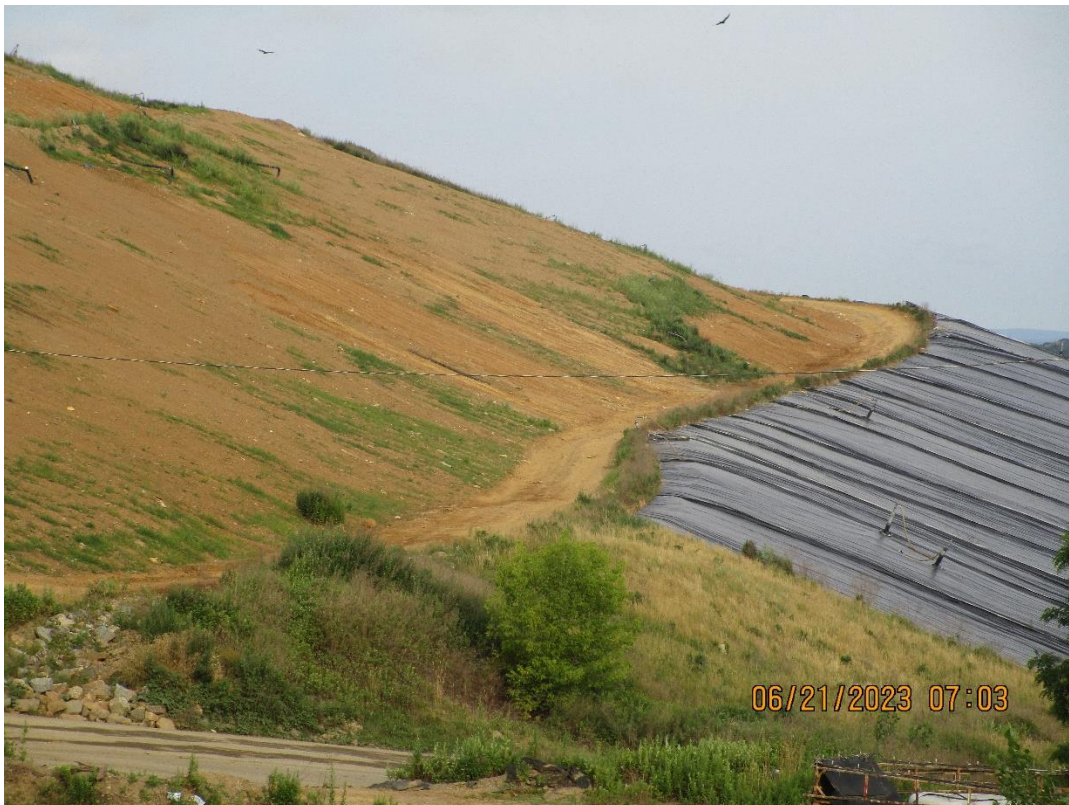
June 9, 2023 DEP Inspection follow-up

Hi Amy,
Here are some follow-up photos of the work we have begun.....leachate seep repair and bench road repair.
