**Municipal Waste Landfill Inspection Report**

Permit Number	100022
Facility Name	CHRIN BROS SANI LDFL
Address	1225 INDUSTRIAL DR
City/State/Zip	EASTON PA 18042-6829
Municipality	Williams Township
Responsible Official	Gregory Chrin
Person Interviewed	Joseph Klobusicky
Lead Inspector	AMY E FAULCH
Site ID	238053
PF ID	240650
Inspection Start Date	12/13/2023 08:26 AM
Inspection Type	RTNC - Routine/Complete Inspection
Permit Expiration Date	01/06/2030

**Site Update – December 5, 2023 – Chrin Landfill**

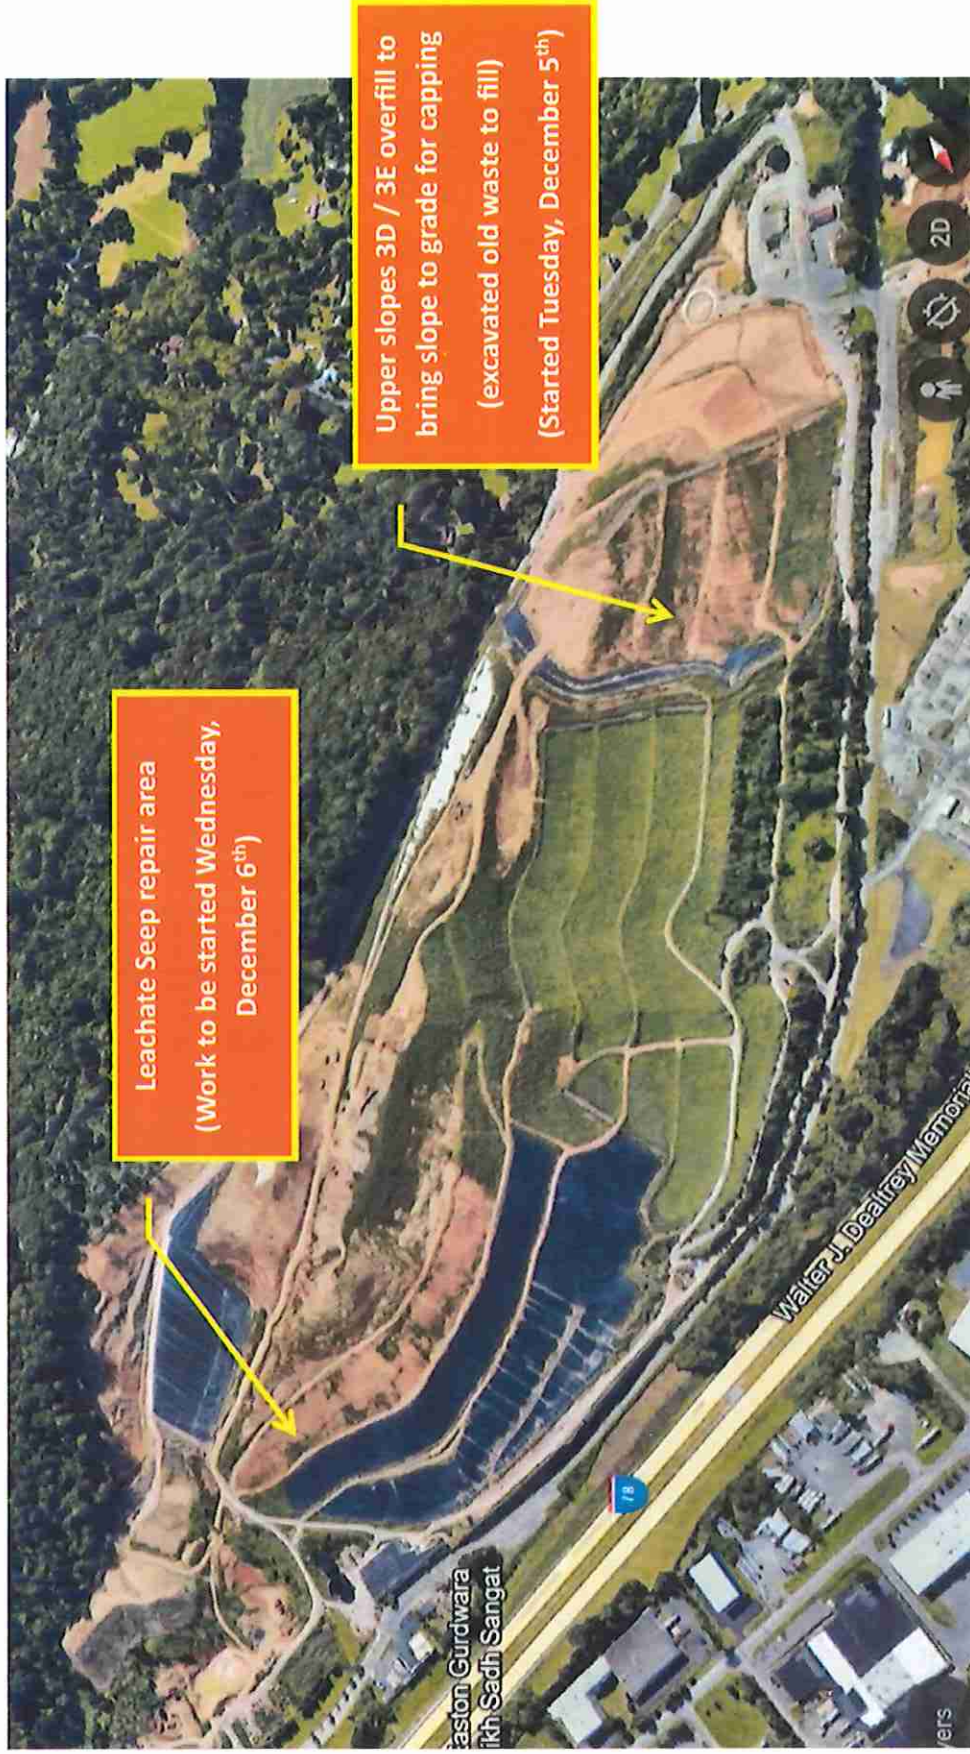
Leachate Seep repair area  
(Work to be started Wednesday,  
December 6<sup>th</sup>)

Upper slopes 3D / 3E overfill to  
bring slope to grade for capping  
(excavated old waste to fill)  
(Started Tuesday, December 5<sup>th</sup>)

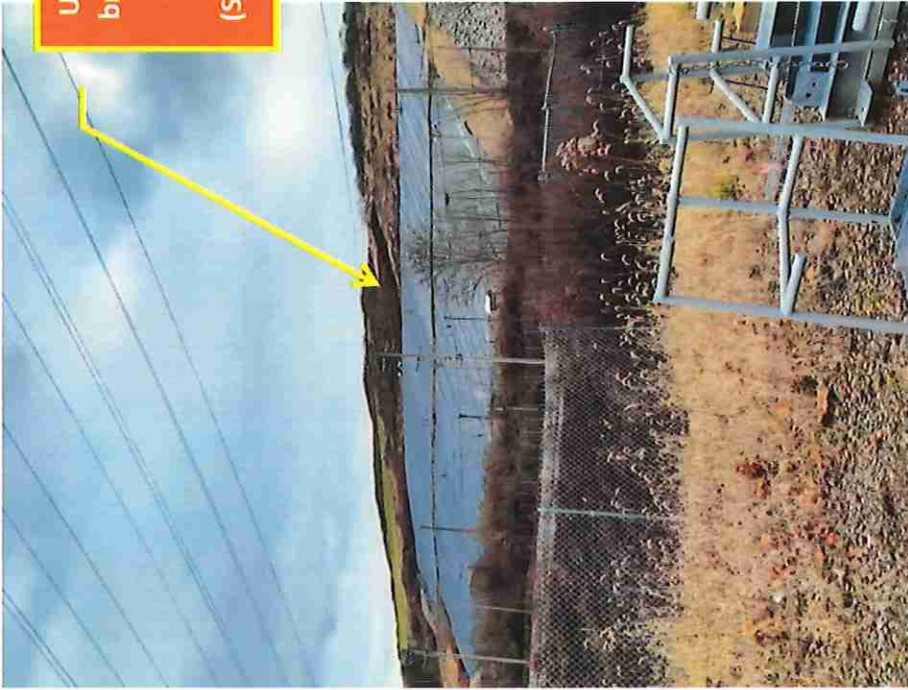
West end of landfill

**Western end of Landfill - Upper slopes 3D / 3E overfill to bring slope to grade for capping (using excavated old waste to fill) (Started Tuesday, December 5<sup>th</sup>)**

Upper slopes 3D / 3E overfill to bring slope to grade for capping (excavated old waste to fill) (Started Tuesday, December 5<sup>th</sup>)

Some gas odors were also detected at the top of 3E near the waste relocation area. The 3E waste relocation area where waste was recently removed west of the working face is in need of some additional cover, as significant flagging was observed in this area. Cover is being removed from some of the 3D/3E slopes and relocated waste is being added to this area to bring it to grade before final capping. Mr. Klobusicky stated that some of the gas wells may be off in this area due to this work.

**Remark:** Flagging was observed in the 3E waste relocation area west of the working face. Additional cover is needed in this area. Chrin is reminded to apply cover in accordance with 25 Pa. Code 273.232 and 273.233 to the 3E waste relocation area at the end of each day after waste removal activities.

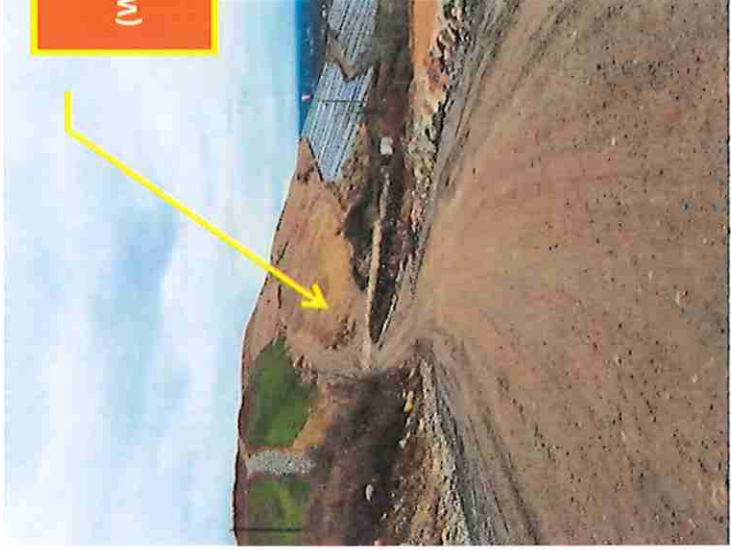
East end of landfill

**Eastern end of landfill - Leachate Seep repair area (Work to be started Wednesday, December 6<sup>th</sup>)**

Leachate Seep repair area (Work to be started Wednesday, December 6<sup>th</sup>)

Some gas odors were also detected along the east access road. Leachate repairs were recently completed in this area. A truckwash was set up along the north access road. The 501 building demolition is continuing. Pyrotechnic "screamers" are being used for bird control.
